## Maintenance Worker Struck by Forklift Carriage—Tennessee

### SUMMARY

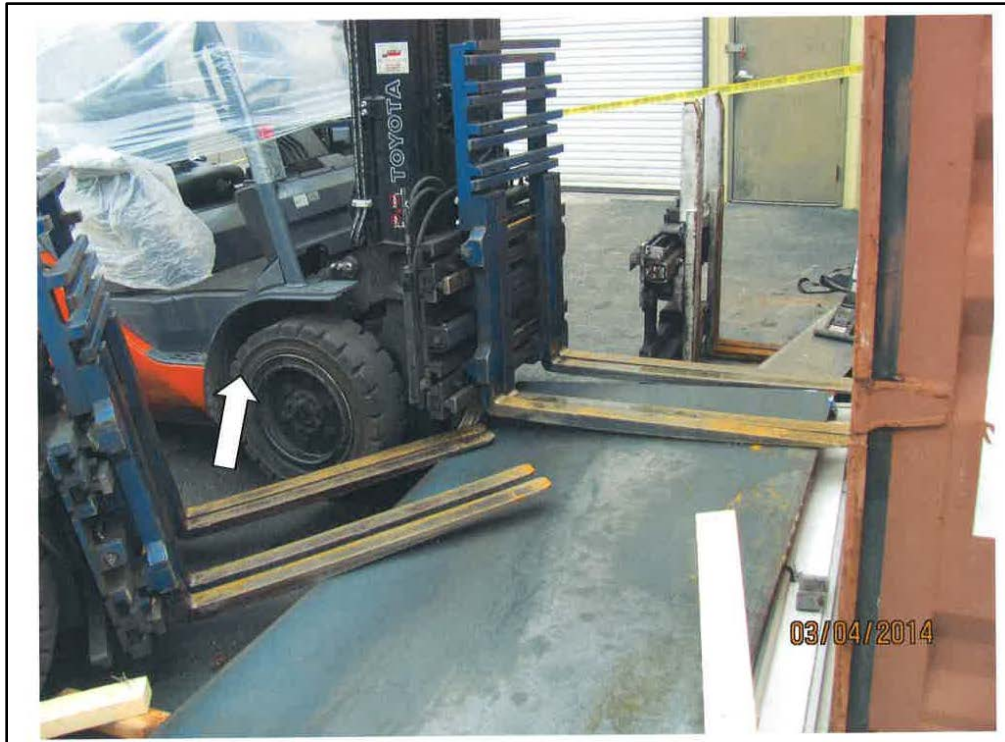
The forklift was being repaired outside near the maintenance shop in a concrete paved yard. A CONEX shipping container was also located outside with a pallet on the ground next to it. The pallet measured 48 inches wide and 12 inches tall. A steel plate and a tractor-trailer door were stacked on the pallet (Photo 1). The pallet with steel plate and tractor trailer door, which was on the ground next to the shipping container, was approximately 51 inches long, and the shipping container was 101 inches tall. The pallet was 7 inches from the mast of the forklift. The forks were 58 inches long (Diagram 1). This allowed only the tips of the forks to rest on the shipping container. After the incident, scratches were observed on the side of the shipping container approximately 1 inch from the top edge where the forks had rested (Photo 2).

**Photo 1. Incident scene, pallet with material on the ground; arrow indicates forklift involved.**  
*(Photo courtesy of TOSHA.)*

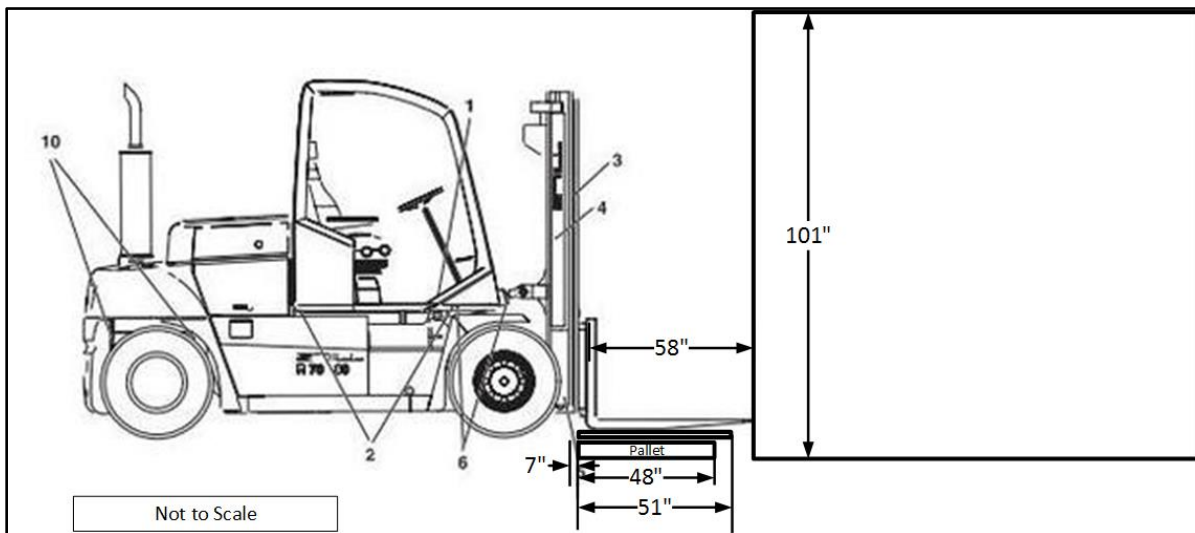
**Diagram 1. Forklift, pallet, and shipping container**

positioned as the maintenance worker wanted it, then set the emergency brake on the forklift, turned off the forklift, and exited the forklift. The pallet on the ground with the steel plate and tractor-trailer door on it prevented the forklift operator from moving closer to the shipping container and allowed only the tips to be placed on the top of the container side.

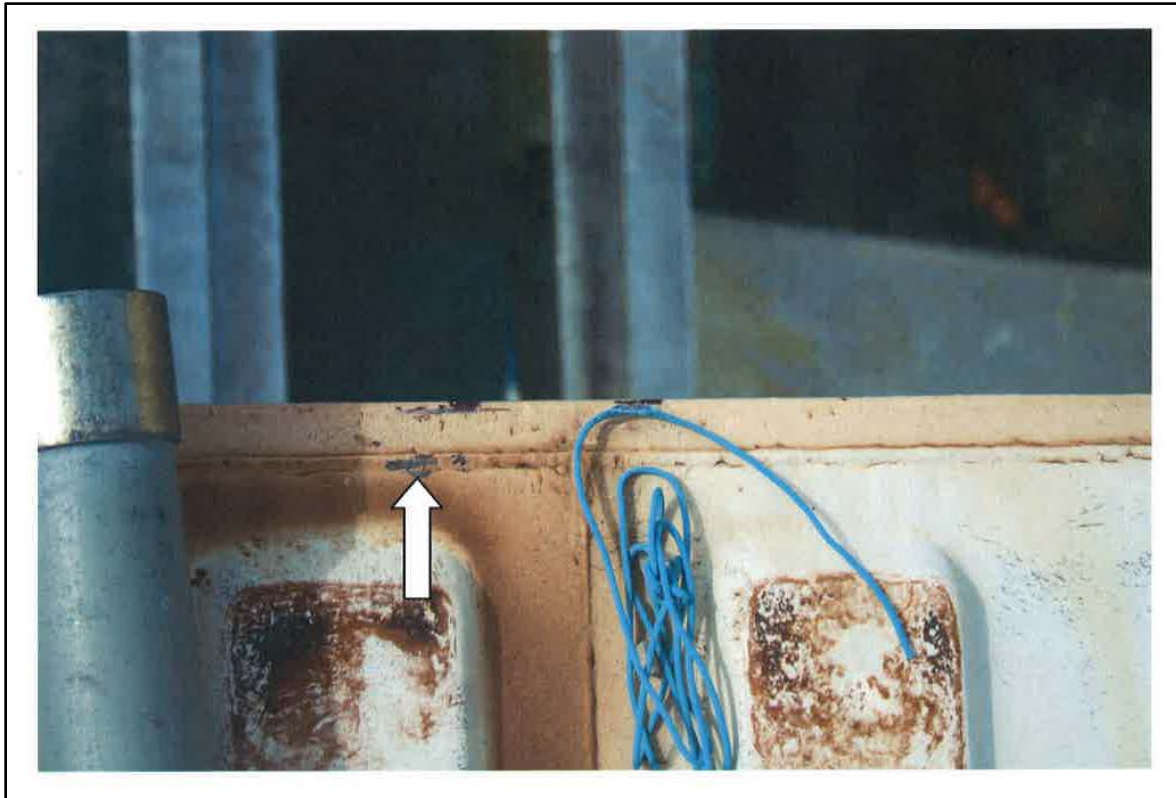
**Photo 2. Arrow indicates scratches on shipping container.**  
*(Photo courtesy of TOSHA.)*

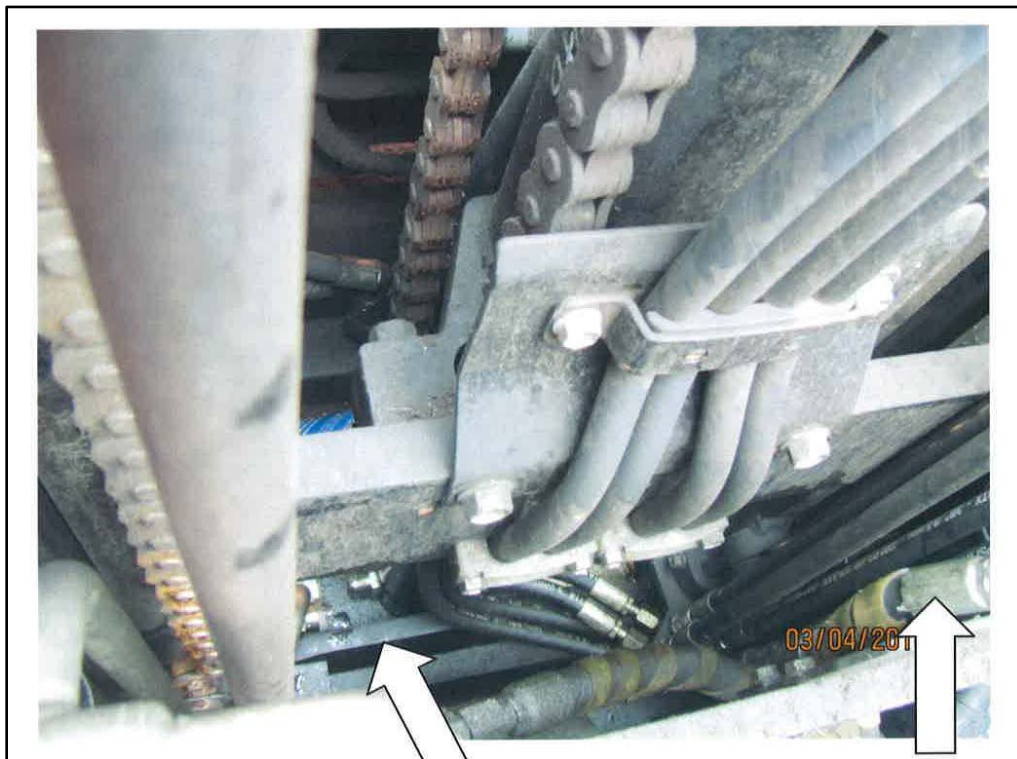
The maintenance worker walked under the elevated forks, kneeled down, and proceeded to examine the hydraulic cylinder. The maintenance worker determined the leak was coming from the hydraulic hose fitting into the hoist cylinder (Photo 3). The maintenance worker and operator went to retrieve a replacement O-ring from the maintenance shop. They returned with the O-ring, and the maintenance worker positioned himself under the forks and began to replace the O-ring. The maintenance worker asked the operator to step out of the way while he repaired the forklift. The maintenance worker sat down on a bucket under the elevated forks, drained the hydraulic fluid, removed the damaged O-ring, installed a new O-ring and began to replace the hose fitting. When the maintenance worker turned the wrench to tighten the fitting, the forks of the forklift were dislodged and slipped off the shipping container. The carriage on the forklift mast fell and struck the maintenance worker in the back of the head, pinning him between the tractor trailer door on the pallet, which was under his feet, and the carriage of the forklift. The operator radioed for 911 and emergency medical services dispatched to the incident. The maintenance worker was then transferred to the hospital where he succumbed to his injuries.

**Photo 3. Right arrow indicates repair location on mast; left arrow indicates where the carriage hit the worker.**

At the time of the incident, the employer did not have specific lockout/tagout procedures to prevent the potential release of energy from a falling forklift carriage. After this incident, the

employer developed a lockout/tagout procedure that included training on removing the fork attachment and using jack stands to support the carriage before relieving hydraulic pressure from the mast lift cylinder.
