**California Department of Public Health
Occupational Health Branch**

**FATALITY ASSESSMENT AND CONTROL EVALUATION
PROGRAM (CA/FACE)**

**A Tree Trimmer is Electrocuted While Trimming a Palm Tree
Case Report: 18CA001**

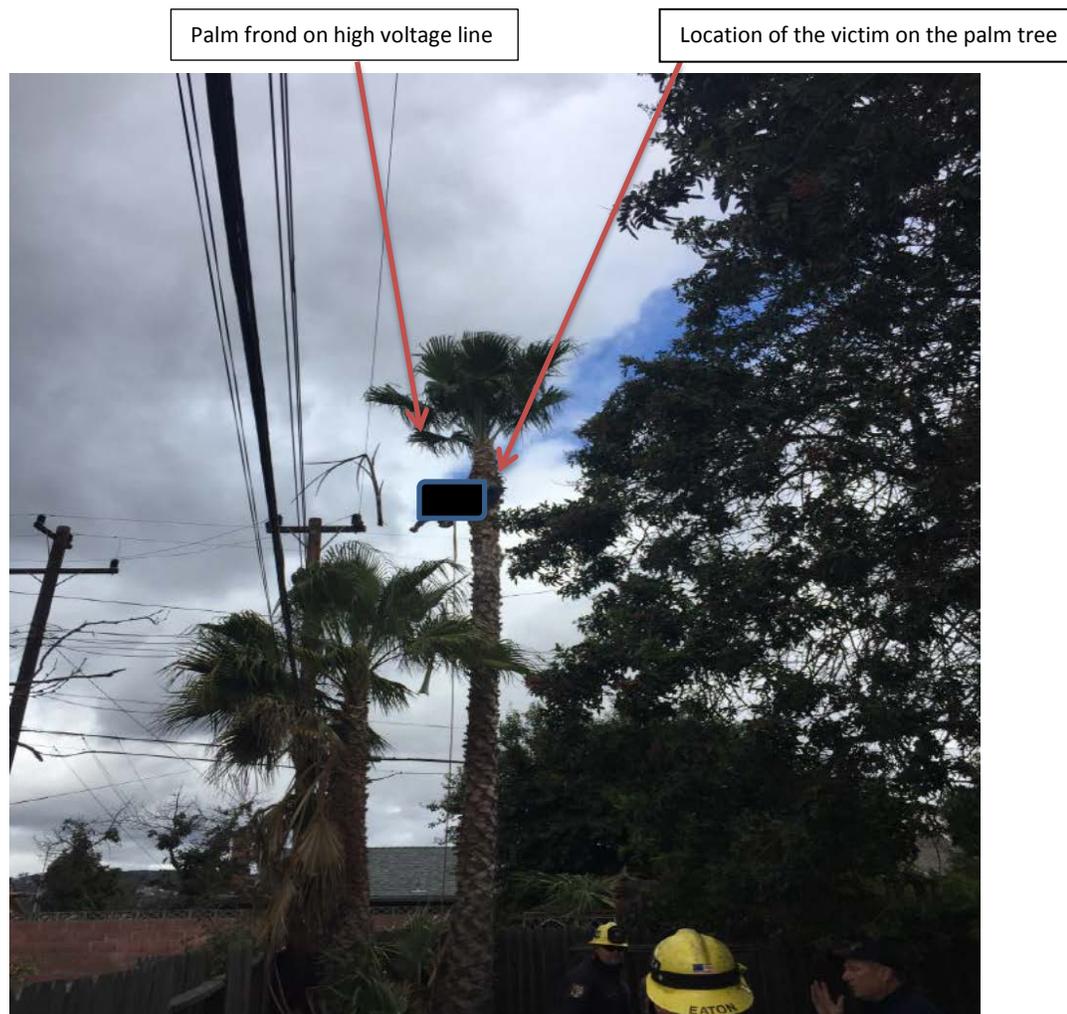
The incident scene was a private residence located on a short cul-de-sac street. The home was managed by a property management company that rented the residence to a private party. This property management company hired the employer of the victim to remove a pepper tree and trim all the palm trees in the front and back of the residence. The residence was a single-story building with an attached garage. The front of the house faced east and the back faced west. The back yard was rectangular in shape with a grass lawn bordered by flower beds and different planted vegetation of shrubs and trees. In the northwest corner of the back yard were three palm trees that had grown to different heights. The tallest tree (the tree involved in the incident) exceeded 50 feet in height and its fronds extended outward within 10 feet from high

voltage power lines. Also located in that corner of the yard was a utility pole that contained numerous communication lines as well as primary and secondary high voltage electrical lines.

Exhibit #1: The palm tree involved in the incident, and its close proximity to the high voltage electrical lines. *Photo used with permission.*

Recommendation #2: Ensure that a qualified line clearance tree worker is used when tree trimming is within 10 feet of energized high voltage power lines.

Discussion: In this incident, the victim and his co-worker did not identify the high voltage electrical lines and were not aware of the dangers associated with working in close proximity to these lines. A qualified line clearance tree worker has knowledge about hazard recognition and

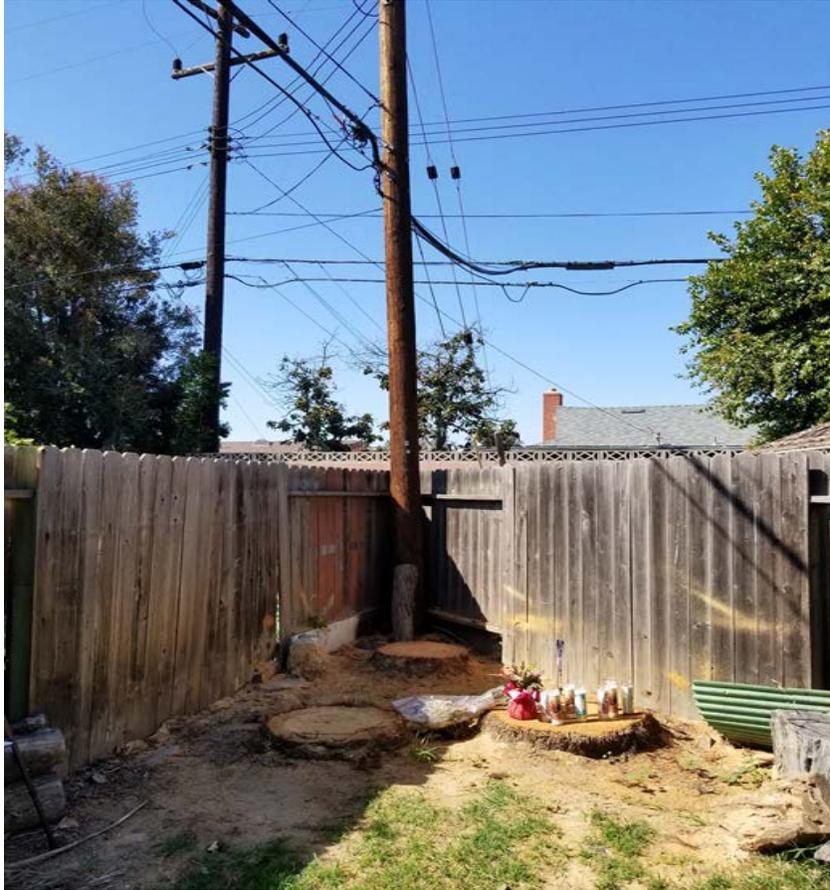
Exhibit #2. The incident scene showing the utility pole, and stumps where palm trees were cut down after the incident. The stump with the candles and flowers on it (a memorial to the victim) is the one involved in the incident. *Photo used with permission.*
