# MIFACE INVESTIGATION REPORT #16MI104

## **SUBJECT: Concrete Finisher Electrocuted When Bull Float Contacted an Energized Power Line**

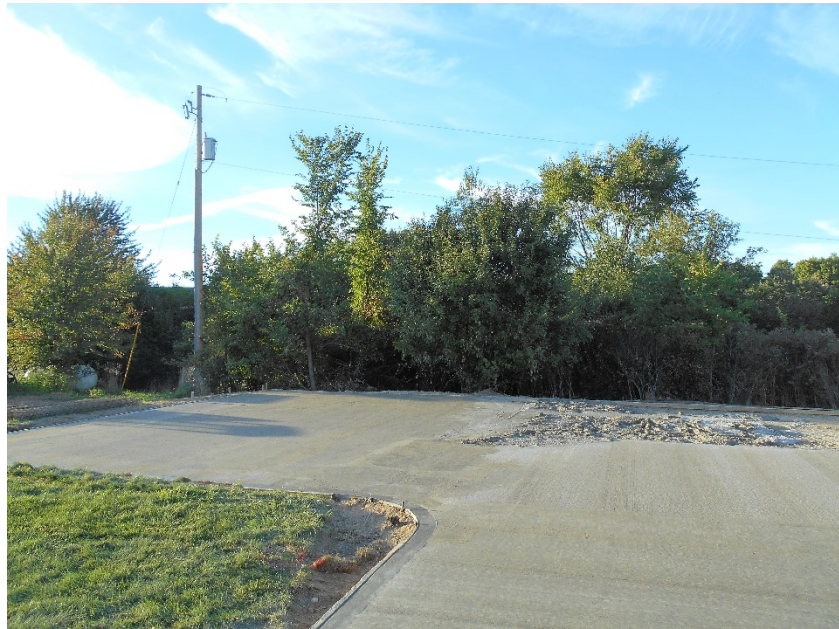
*Figure 1: Overview of incident scene*

pole. The utility company measured the height of the two overhead lines after the incident. The bottom neutral line was 17 feet high and the 7,200-volt primary line was 23-feet high vertically and 24 feet from the edge of the concrete forms. There were two visible impact burn points on the wire. One was a 1.5-2-inch width of the bull float pole and the second contact was approximately 2.3-3.0 feet long where the pole may have slid along the wire. Emergency response was called and the decedent was transported to a local hospital where he died.

As the slab being poured was approximately 33 feet wide, the decedent had to walk around the edge of the slab in order to reach the entirety of the concrete being poured. The decedent began the process of smoothing the poured concrete on a patch of lawn directly adjacent to the garage, in the southwest corner of the driveway. From there, he moved north along the western edge of the driveway repeating the process, before he relocated along the northern edge of the driveway around 9:30 AM (Figure 1, photo facing north).

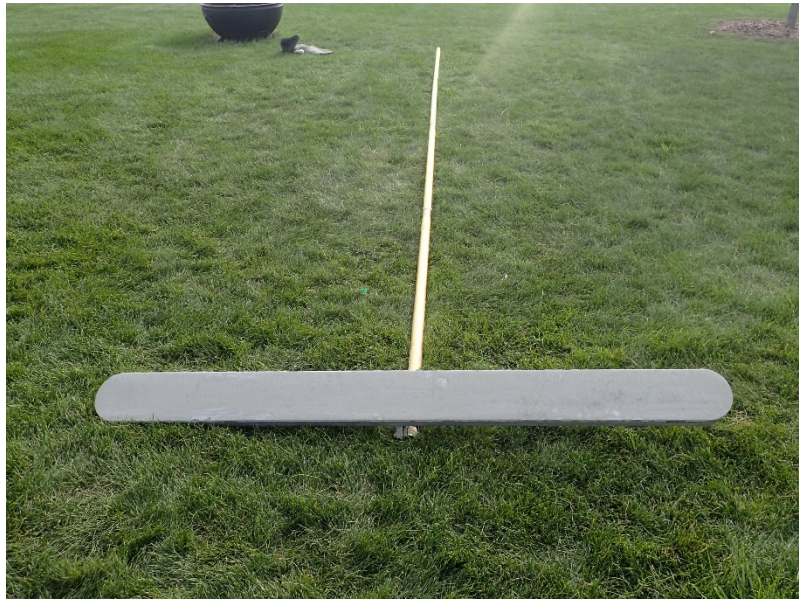
An employee was engaged in concrete finishing work, when the 29-foot aluminum handle of his bull float came in contact with a 7200-volt overhead power line.

driven into the ground. Concrete pouring commenced around 8:00 AM. The decedent was reported to have used a bull float attached to four or five 6-ft aluminum handles connected in sequence, which gave him approximately 24-30 feet of reach. This was corroborated by the MIOSHA investigation that stated that the bull float had 29 total feet of reach. The handles were connected to the float via a mechanism that altered the angle of the handle-float joint via the axial rotation of the handles, which allowed for the float to maintain level contact with the concrete along the length of its use without progressively elevating the handle as the float was drawn nearer (Figure 2).

*Figure 2: Bull float used by decedent.*

While the owner was aware of the availability of non-conductive handles and had used them in the past, he stated that they did not use them regularly because of their increased weight compared to the aluminum handles, that non-conductive handles were less durable, and the holes through which the non-conductive handles screwed into the mechanism on the float that enables the angle of the float to be changed via the rotation of the handle would widen with use, requiring a greater rotation for a given change in angle and decreasing the mechanism's efficiency. Consequently, each of the handles connected to the float used by the decedent were composed of aluminum.

- Use bull float handles that are non-conductive and/or insulated.

MIOSHA Construction Safety Standard, Part 25 Rule 2520 states that the handle of a bull float being used near an energized electrical conductor must be either constructed of nonconductive material or insulated in a nonconductive sheath. These requirements aside, according to the employer he and many other contractors are aware of the availability of such nonconductive handles, but have frequently chosen to continue using aluminum handles because of weight and durability concerns. However, these concerns can be mitigated at least partially by restricting the use of non-aluminum handles to only those work sites where electrical hazards have been identified during the worksite hazard assessment, prolonging the lifespan of the non-aluminum handles. Worker rotation can also be used if the increased weight of non-conductive handles leads to more frequent exhaustion on the part of the worker using the float. Since the incident, the employer has purchased multiple fiberglass handles and has instructed employees to use them when working near overhead power lines.

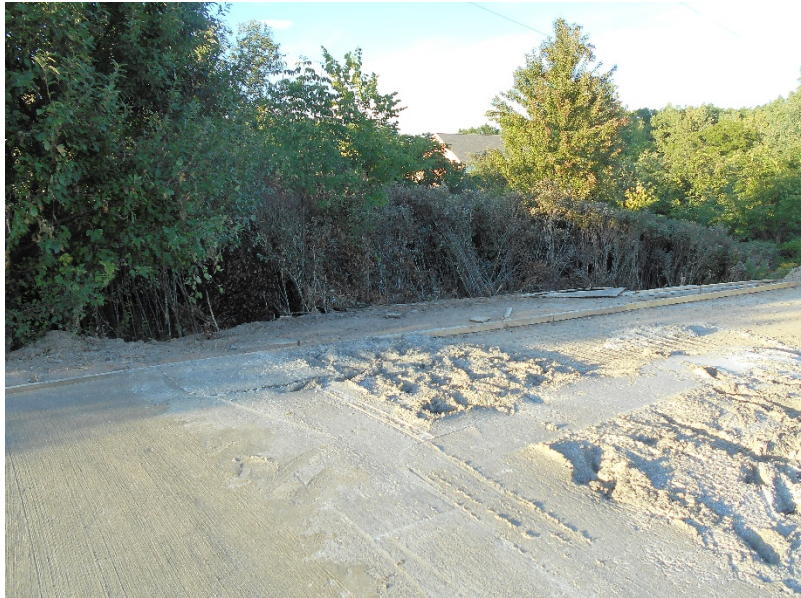
Once along the northern edge of the driveway, the decedent was unable to hold or use the entirety of the bull float handles horizontally, as the vegetation along the top of the gully began approximately 8 feet behind him (Figure 3). This may have required him to elevate the 29-foot handle more than usual. Once elevated, the handle made contact with the energized power line.

*Figure 3: Vegetation along north end of worksite*
