SAFETY FLASH NO.: SF2012-022

Significant Near Miss Involving a Fiberglass Extension Ladder

Ladder Inspections - Why they are so Important

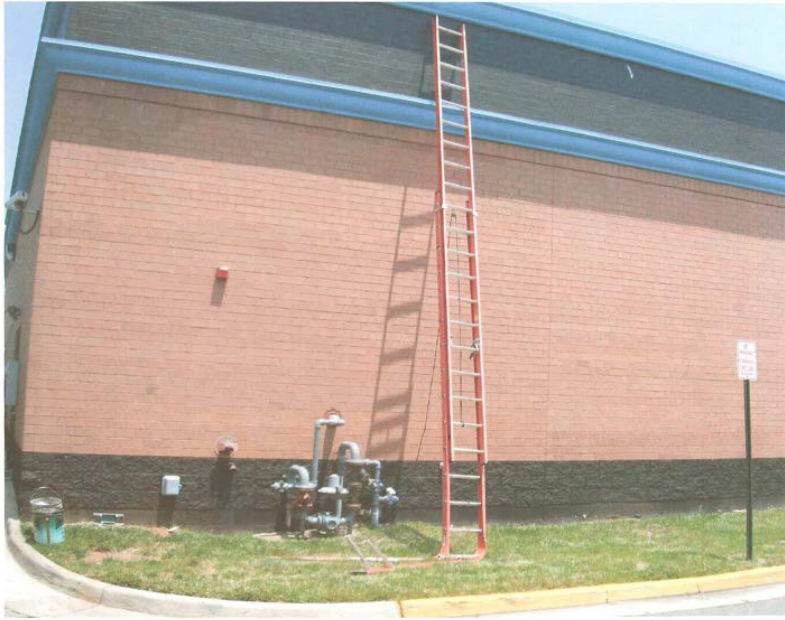
Ladder collapsed – worker was able to grab on to the leading edge of the building

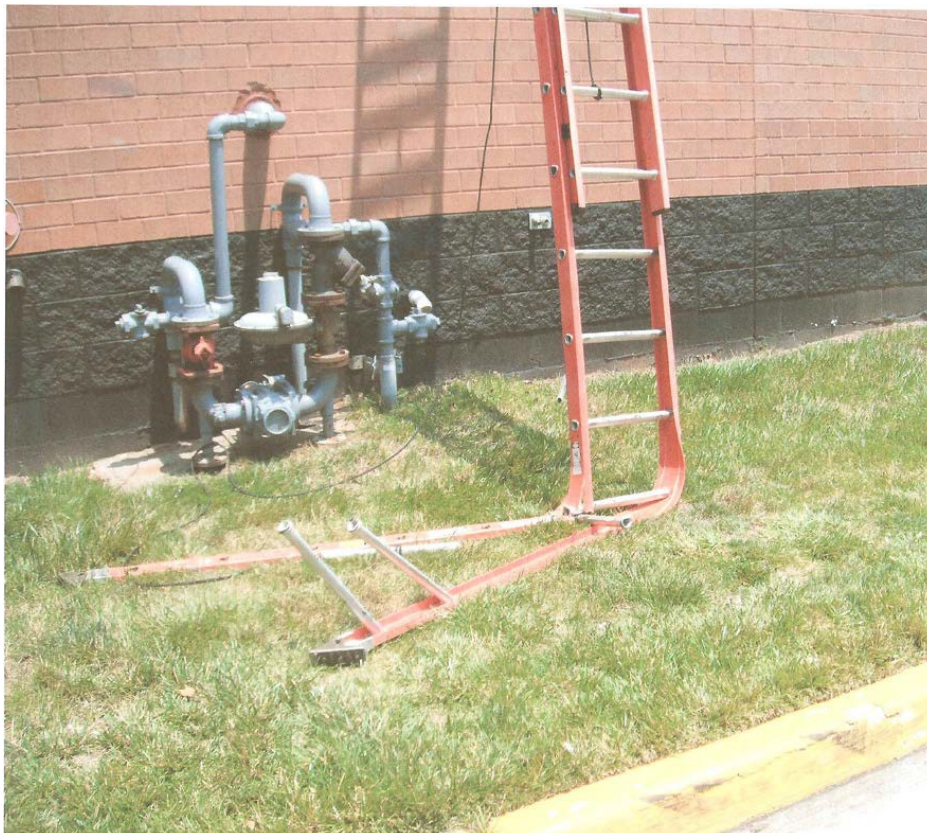
The lower section of the ladder failed

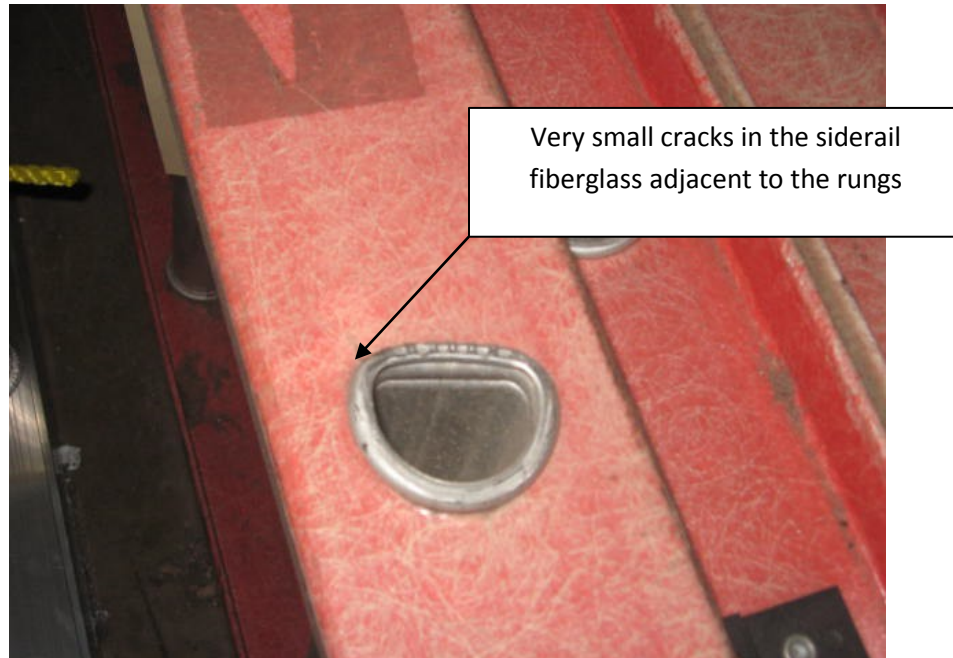
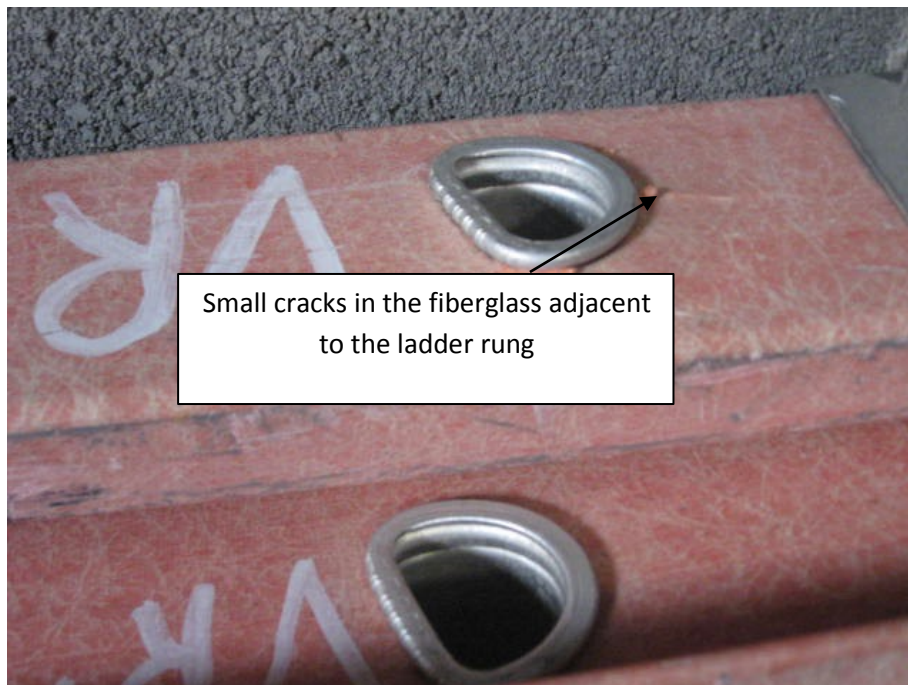
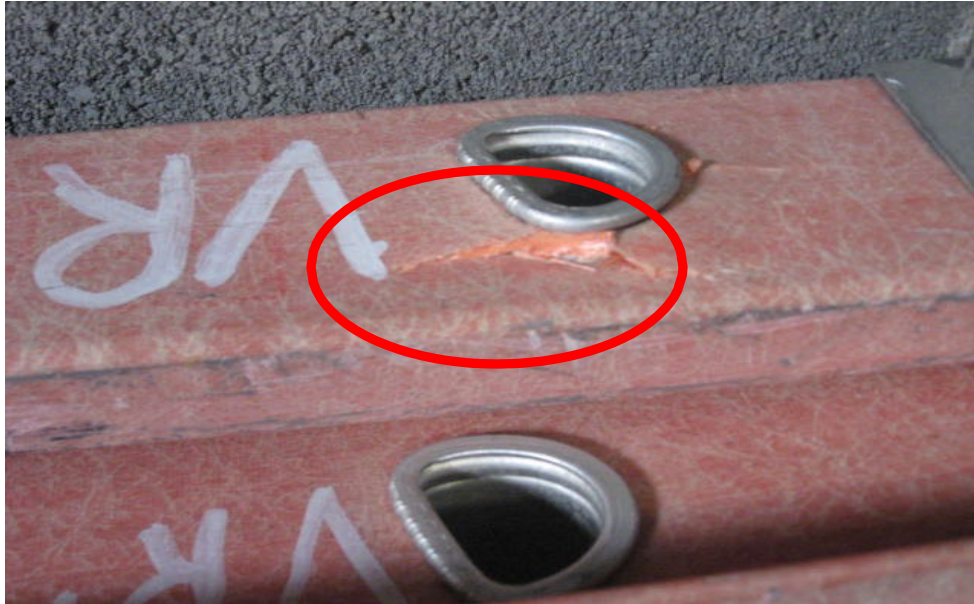
All fiberglass ladders were immediately brought in from the field and closely examined for any possible defects or damage. The company found that on approximately 20% of their fiberglass extension ladders there were very small cracks in the fiberglass on the siderails immediately next to the rungs of some ladders.

In addition to the small cracks in the fiberglass in some areas the fiberglass material had split.

The small cracks found in the siderails of the extension ladders were not noted to be in any pattern along the siderail. The cracks and splits in the fiberglass were found to be immediately next to the rungs on the outside portion of the siderail.

Currently it is believed the fiberglass may have been damaged or fatigued during the manufacturing process when the rungs were crimped into the siderail of the ladder.

The small cracks around the rungs are not easily detected by a quick visual inspection. Workers need to 'feel' with their finger tips for any raised spots in the fiberglass and remove any debris along the side rails in the areas where the rungs are crimped to check for small cracks or splits. The cracks were not found in any pattern or specific location on all the ladders inspected. It is important to inspect each rung on both the exterior and interior side of the siderail for any signs of cracks or splits in the fiberglass.

Any fiberglass ladder with these small cracks should be removed from service.
