Fall Arrest or Save Evaluation Report

Type of Construction: Residential framing, single family home

Incident Scene

Carefree, Arizona

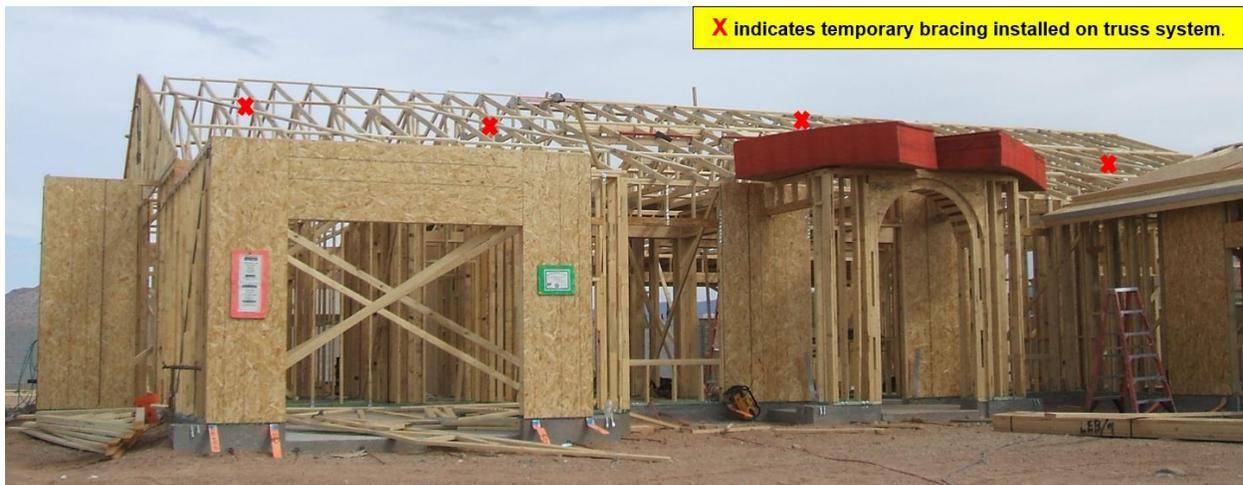
Figure 1. House in Frame just after trusses erected and set. Stack of OSB above entryway to the right was being put into position when worker fell.

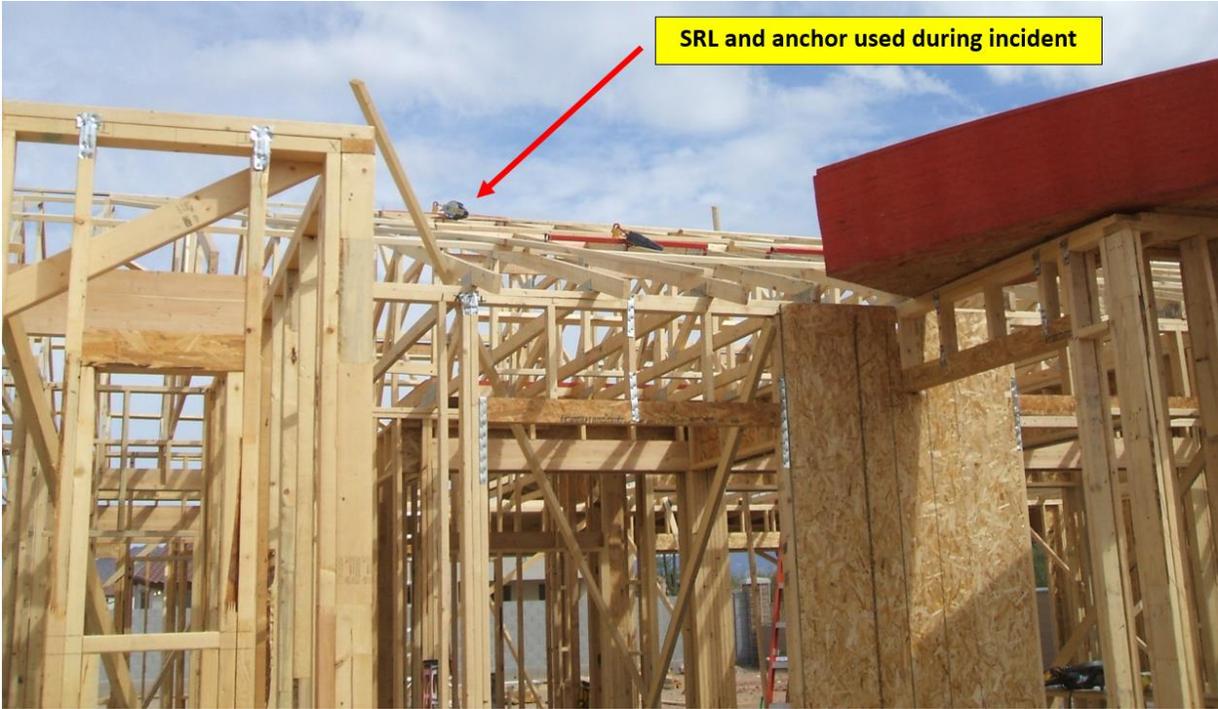
Figure 2. PFAS anchor and SRL used by the worker. All equipment left in place for photo.

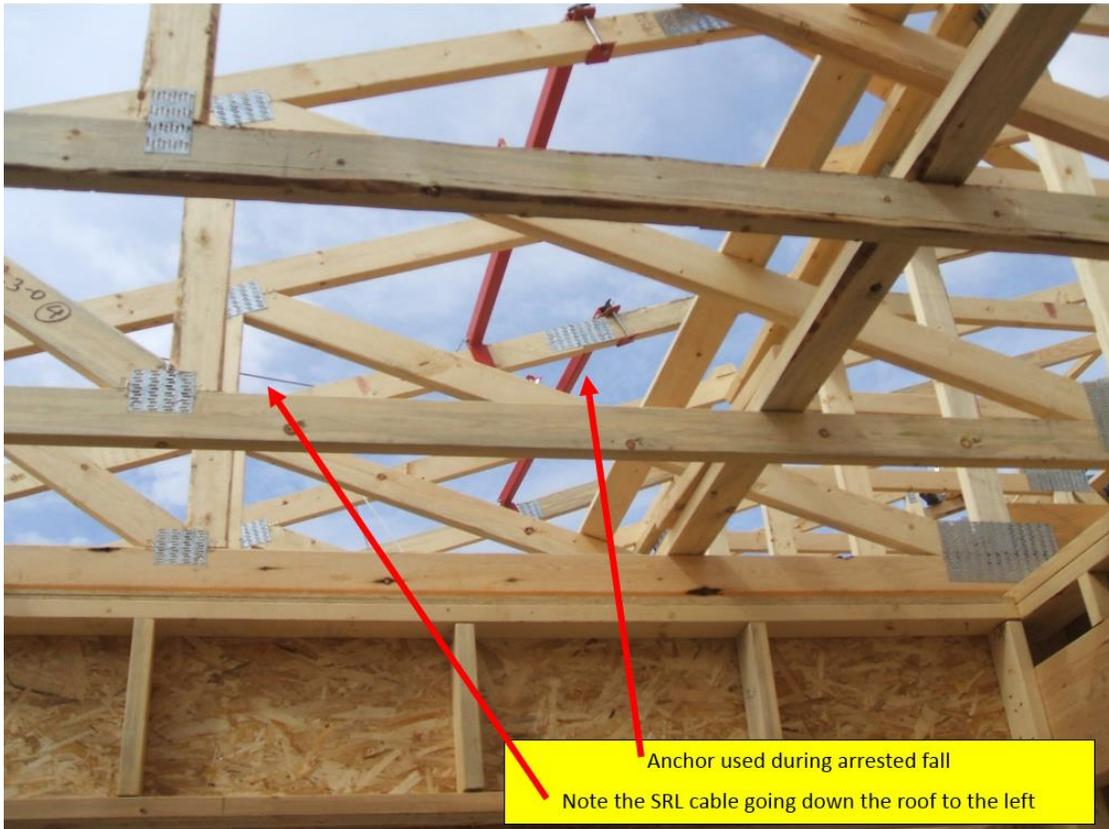
Figure 3. Underside of truss system and anchor used in arrested fall.

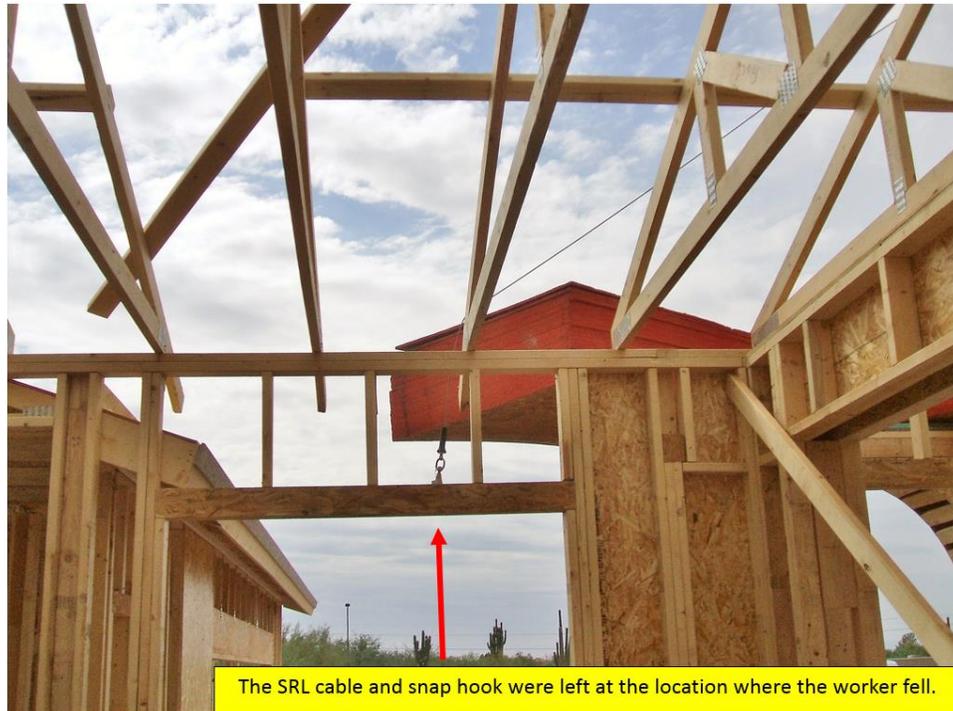
The SRL cable and snap hook were left at the location where the worker fell.

Figure 4. SRL cable and snap hook where fall was arrested. Note proximity to truss top chord and wall and path of lanyard over truss tail.

- The worker fell between truss tails. As he fell, the lanyard passed over the truss tail into the corner created by the tail and top plate and limited the amount of swing. (See Figure 4)

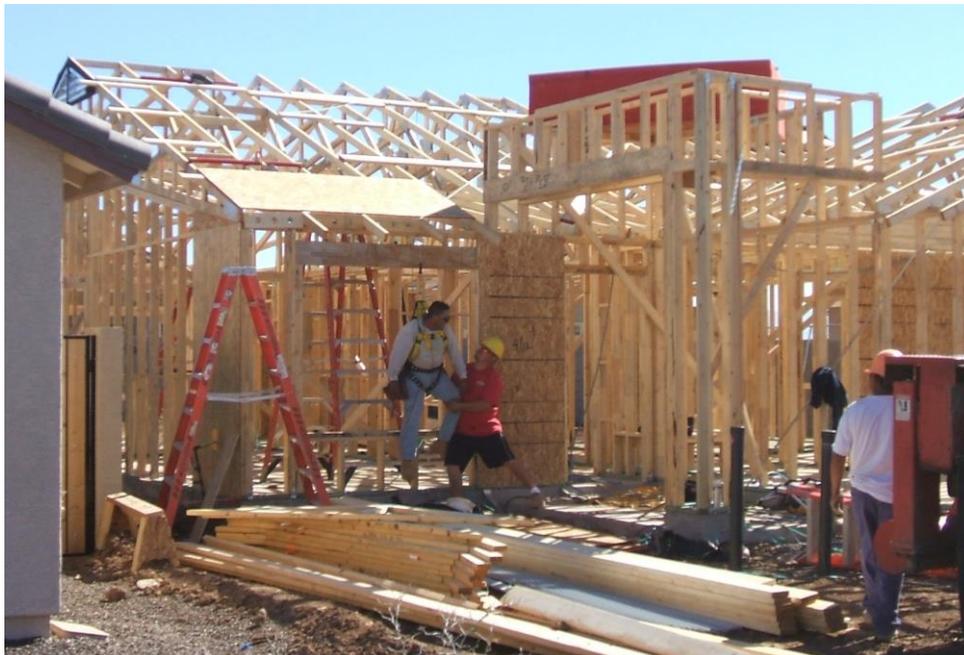
Figure 5. Worker who fell demonstrating his final position and subsequent rescue. After the arrested fall, both workers demonstrated the rescue at a similar location. The worker who fell is shown in the following figure demonstrating his height above the ground where he came to rest and reenacting with the other worker how he was rescued.

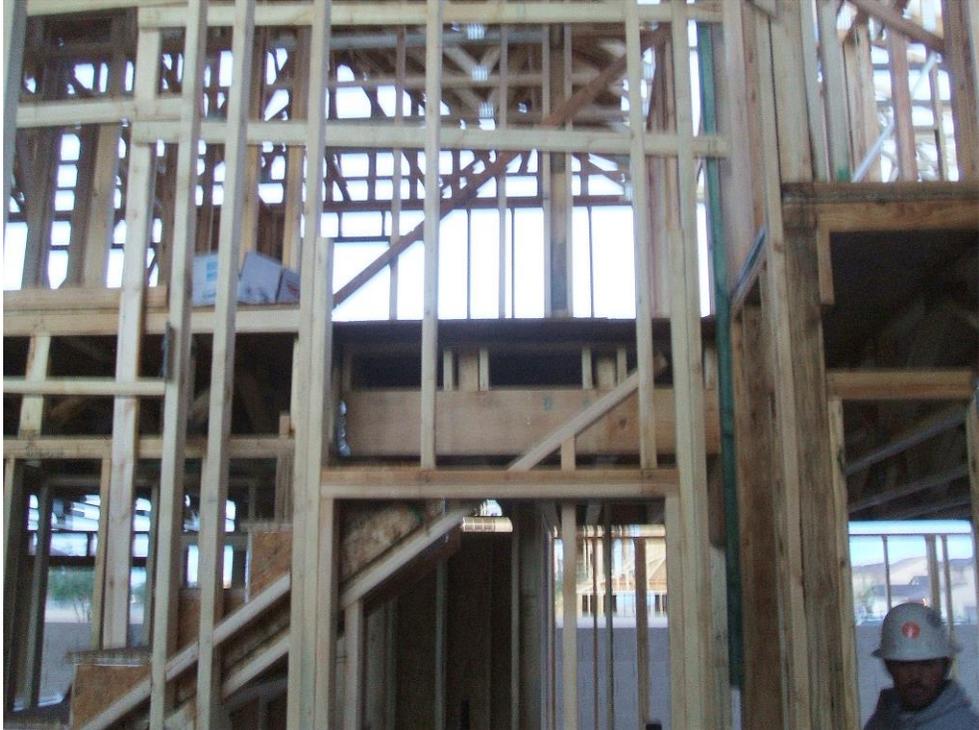
Figure 2. Ground floor view of deck edge where worker stepped off backwards.

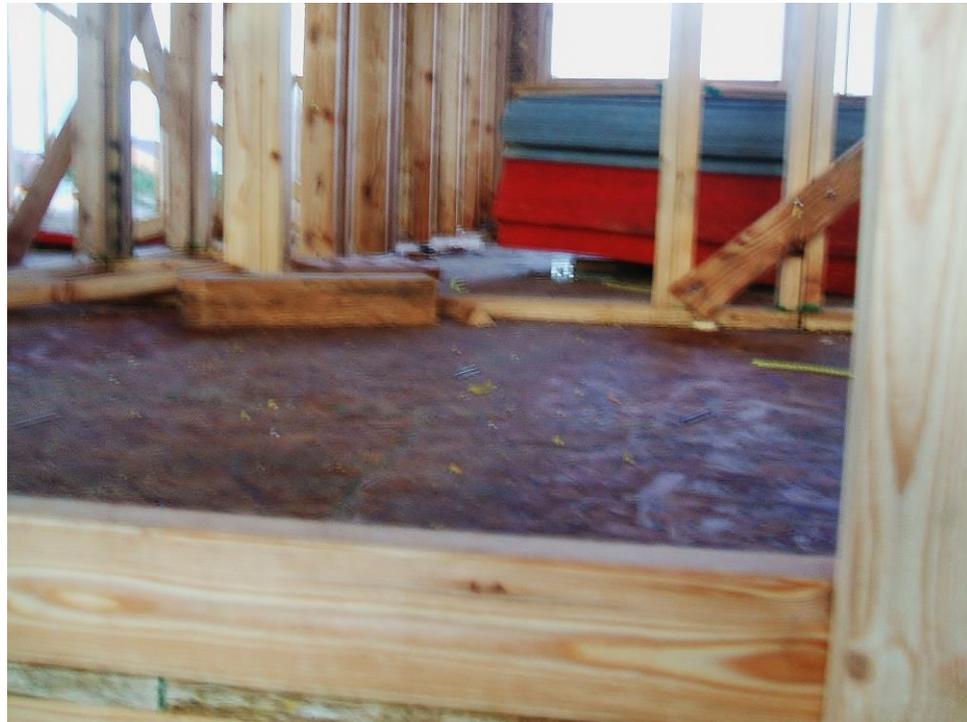
Figure 3. Anchor location.

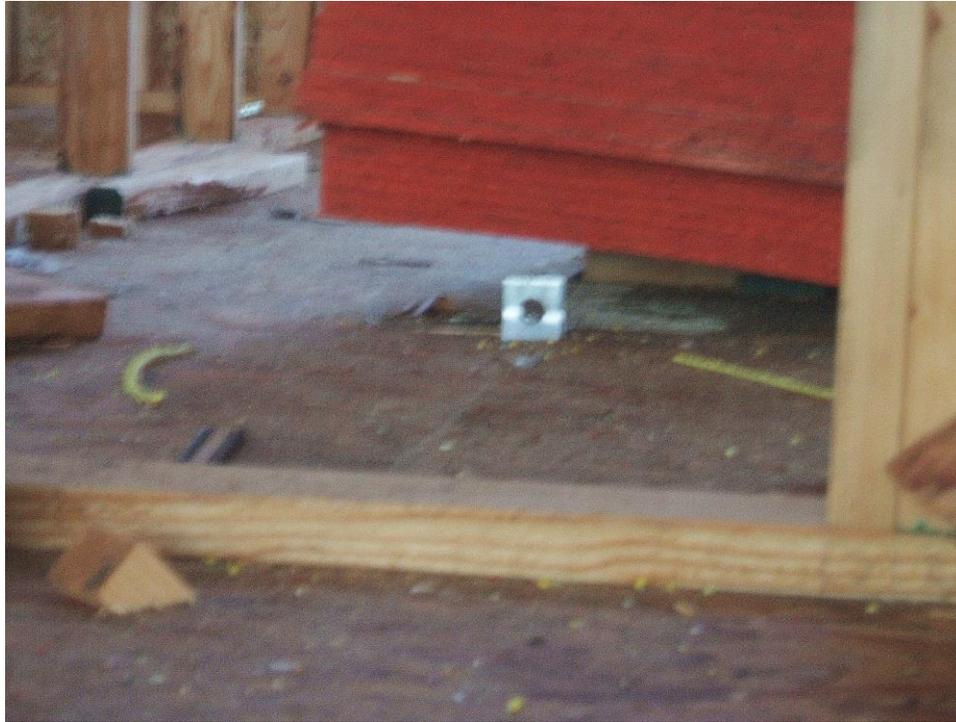
The anchor, which cost about \$5.00, was meant to be temporary and was installed over floor decking directly over a structural floor truss.

Figure 4. Close up of \$5.00 anchor

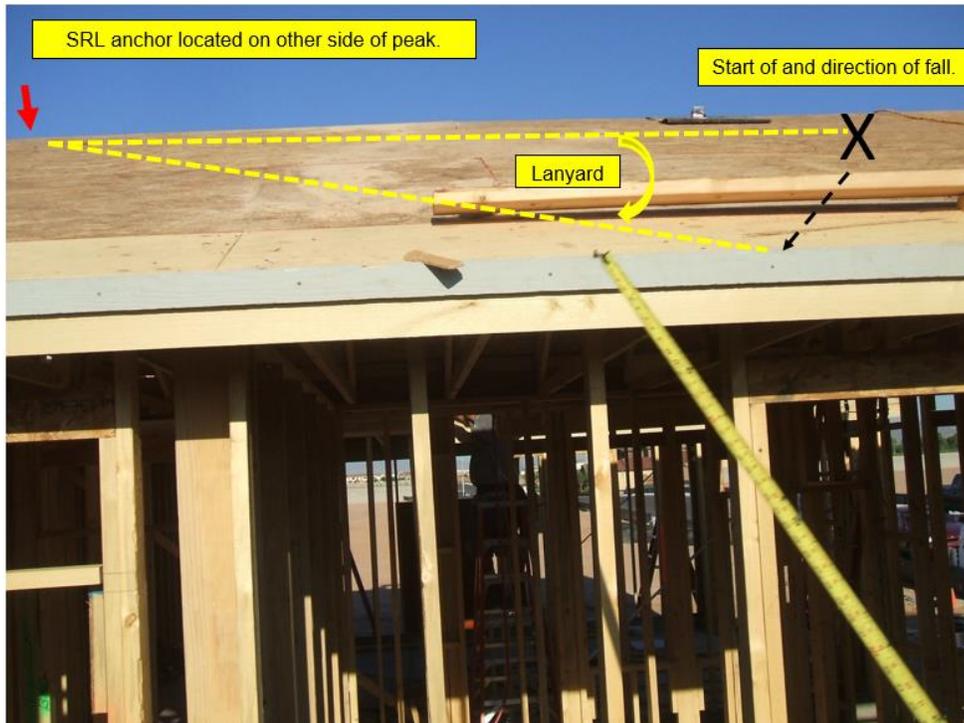
Figure 2. View from below where worker went over edge of roof

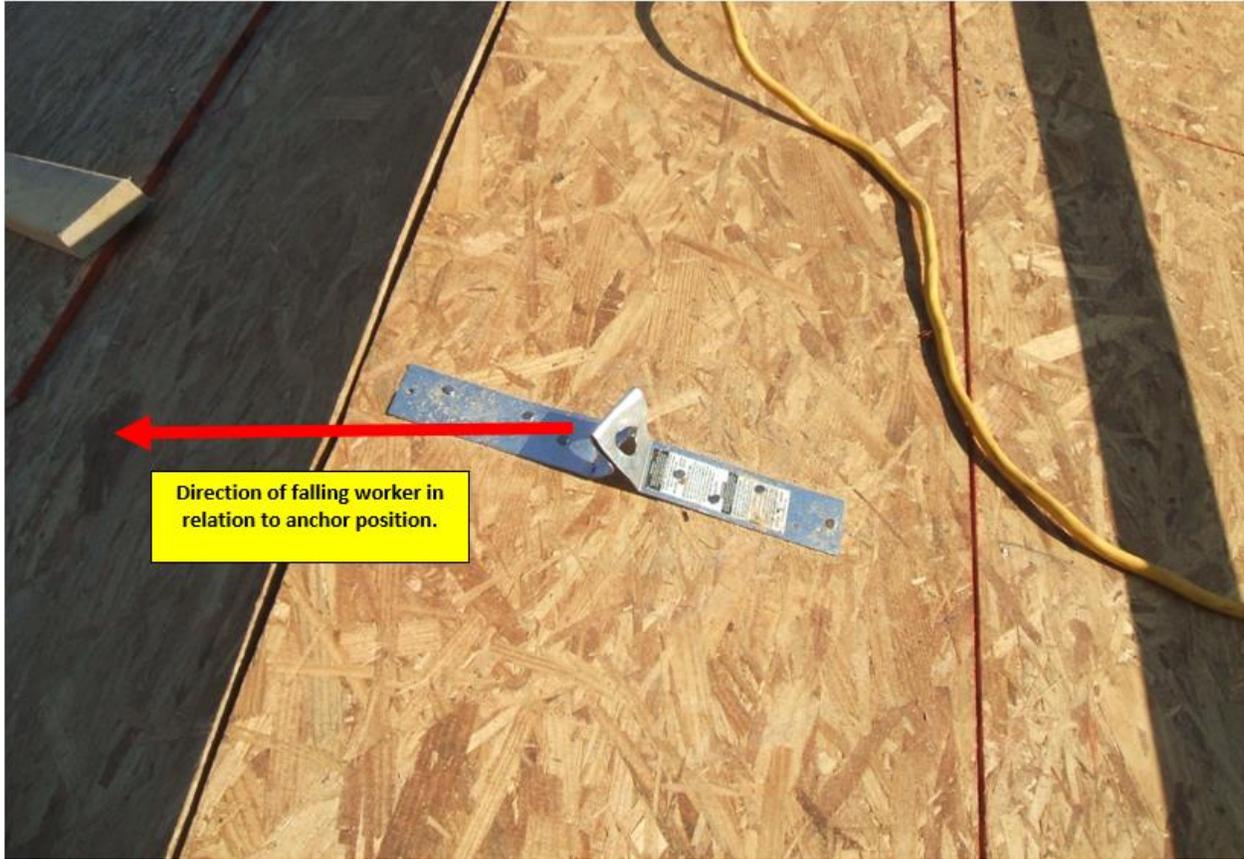
Figure 3. Anchor in proximity to ridge.

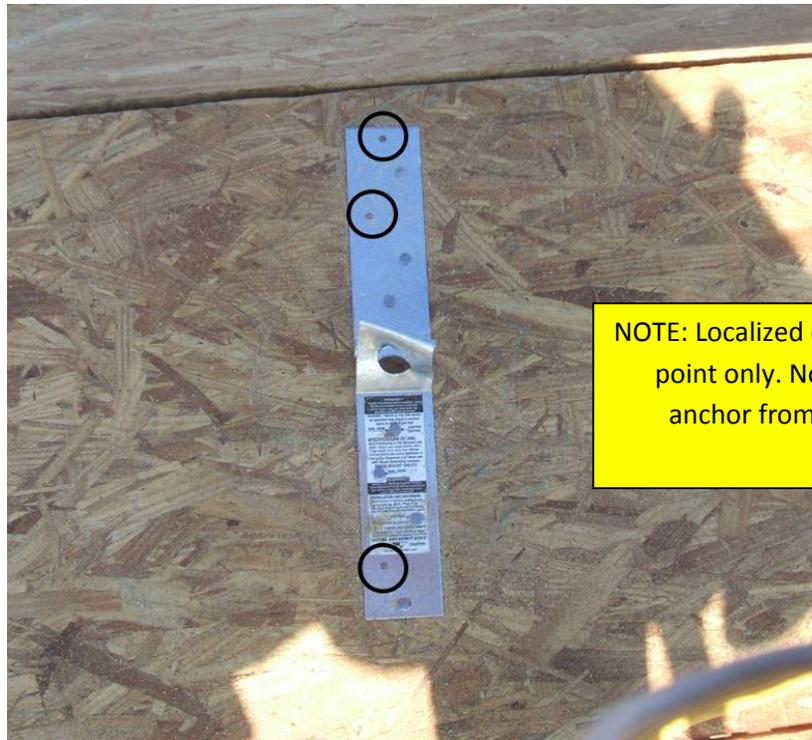
Form-It was installed over sheathed and braced trusses in accordance with manufacturer instructions. Of note is that of the 10 nails required to install the anchor, three were missing.

NOTE: Localized deflection of anchor point only. No pulling away of anchor from roof structure.

Figure 4. Anchor deformation after incident. Circles denote missing nails.

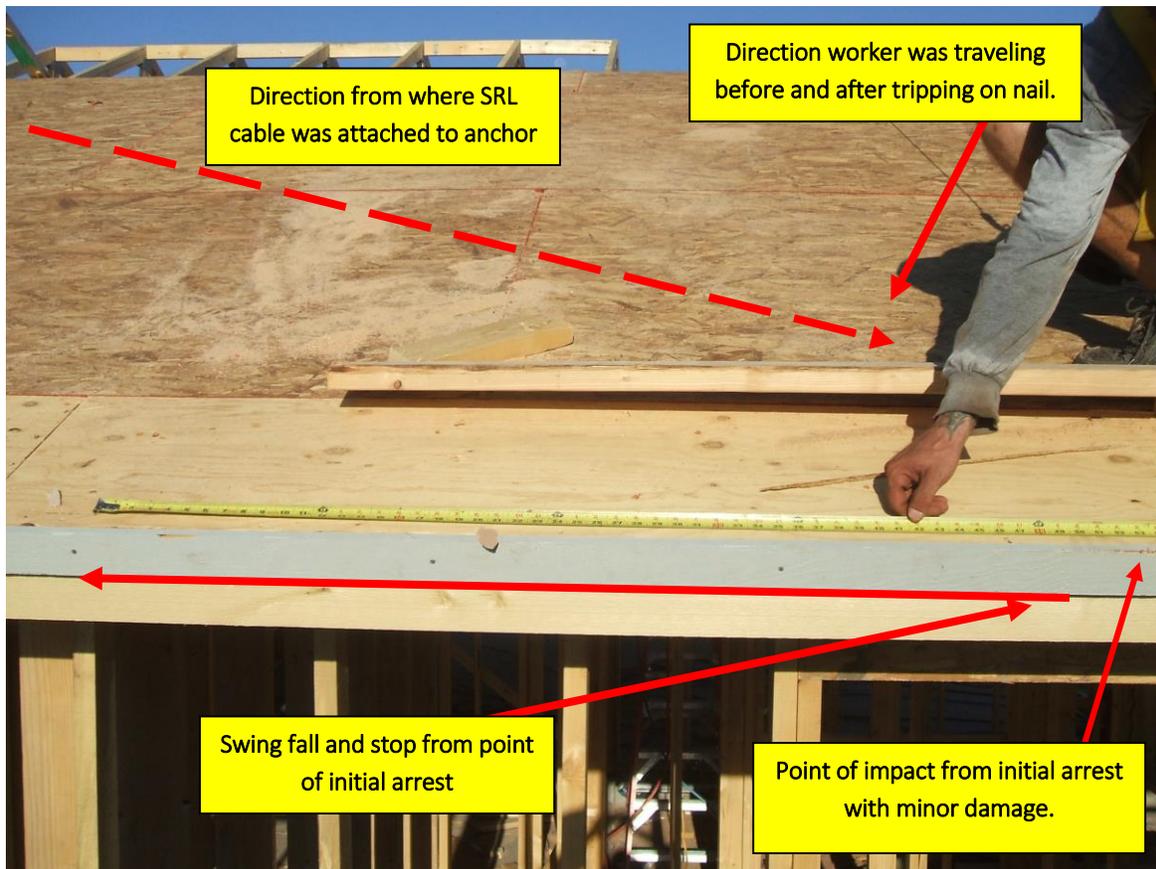
Direction from where SRL cable was attached to anchor

Direction worker was traveling before and after tripping on nail.

Point of impact from initial arrest with minor damage.

Figure 5. Motion of swing fall including minor shingle mold damage.

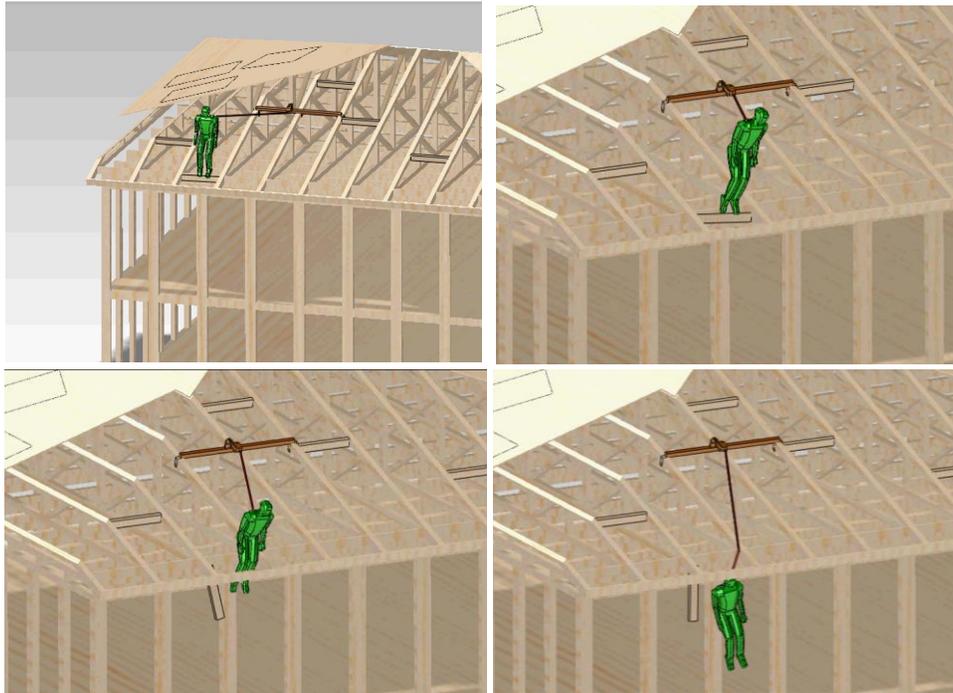
Sequence of fall kinematics

The cause of the fall was the employee's failure to correctly nail a block (commonly referred to in the trade as "short nailed"). Because it was not nailed correctly, when the worker stepped on the block it became unfastened from the wall, causing him to fall. The kinematics of the arrested fall are demonstrated in the following sequence.

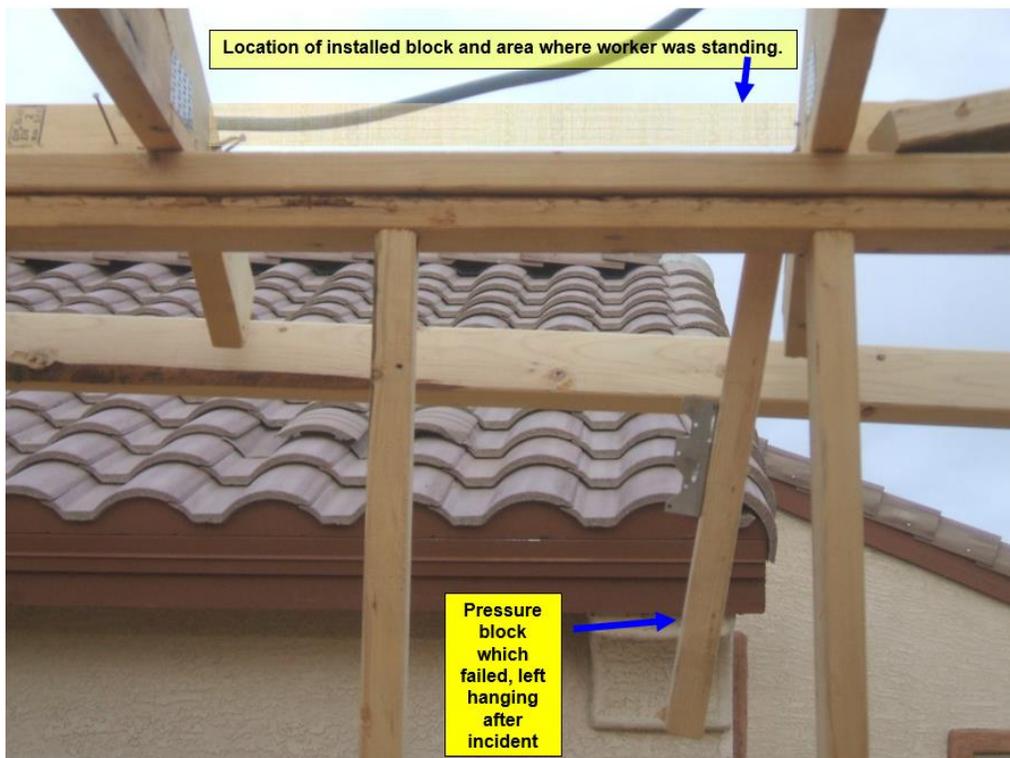
Figure 3. Location of incident from second floor vantage point as seen on date of incident.

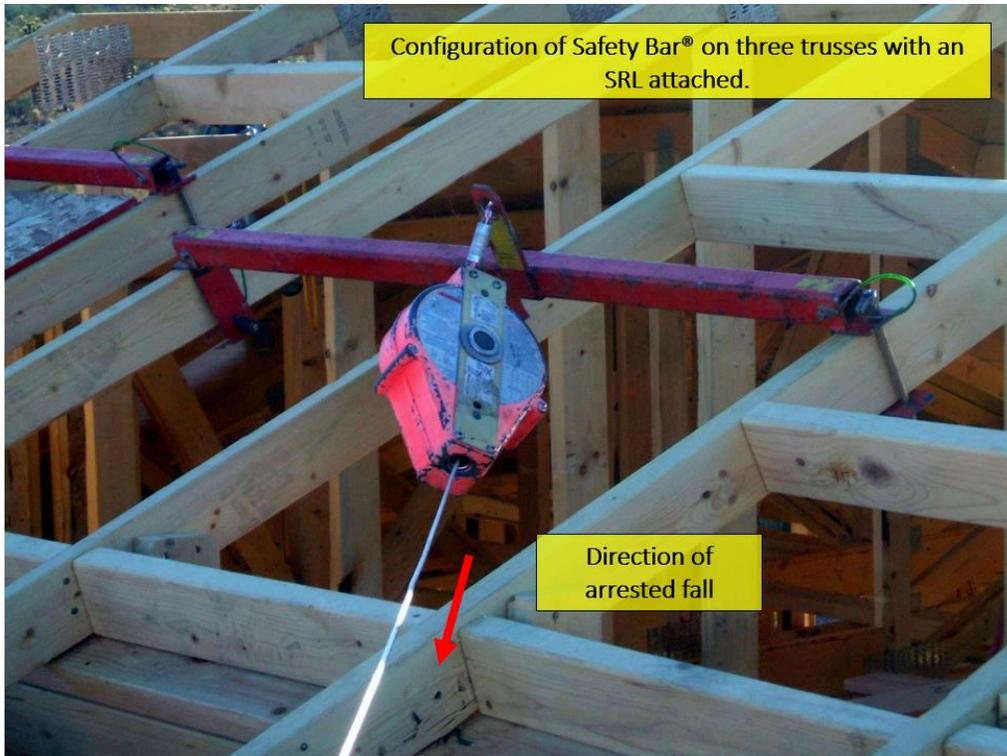
Figure 4. Illustration of how anchor was installed with SRL lanyard extended on day of incident.

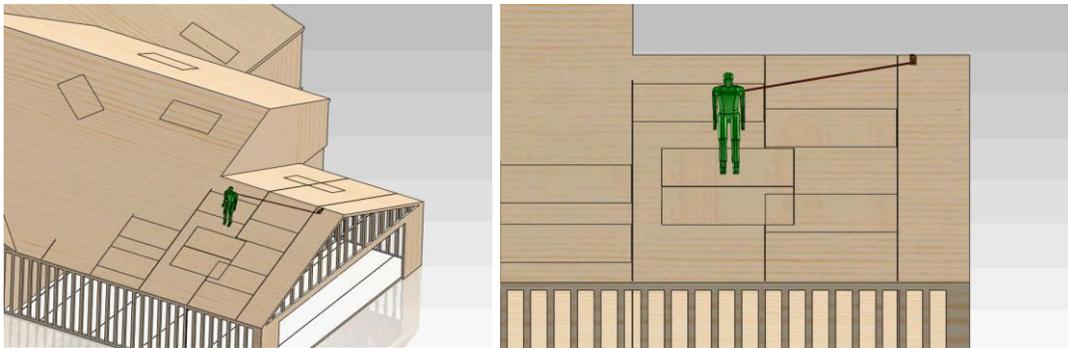
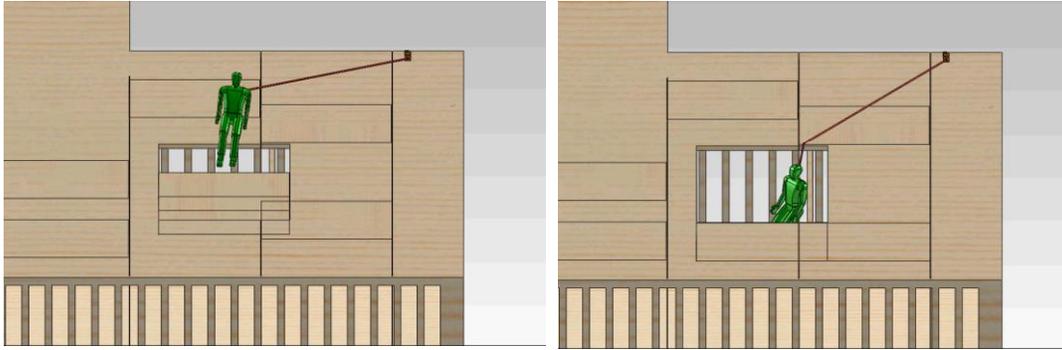
Sequence of fall kinematics

Upon review of the incident and report made by the foreman (who watched the entire incident only six feet in front of him), it was determined that the fall protection system acted exactly as designed. The worker, whose previous construction experience was in steel erection, was not fully aware of wood frame techniques to comprehend how important it was to properly secure sheathing. Although the worker stated he had experience with using PFAS in steel construction, this was the worker's first day using fall protection systems in residential construction. The kinematics of the arrested fall are demonstrated in the following sequence.

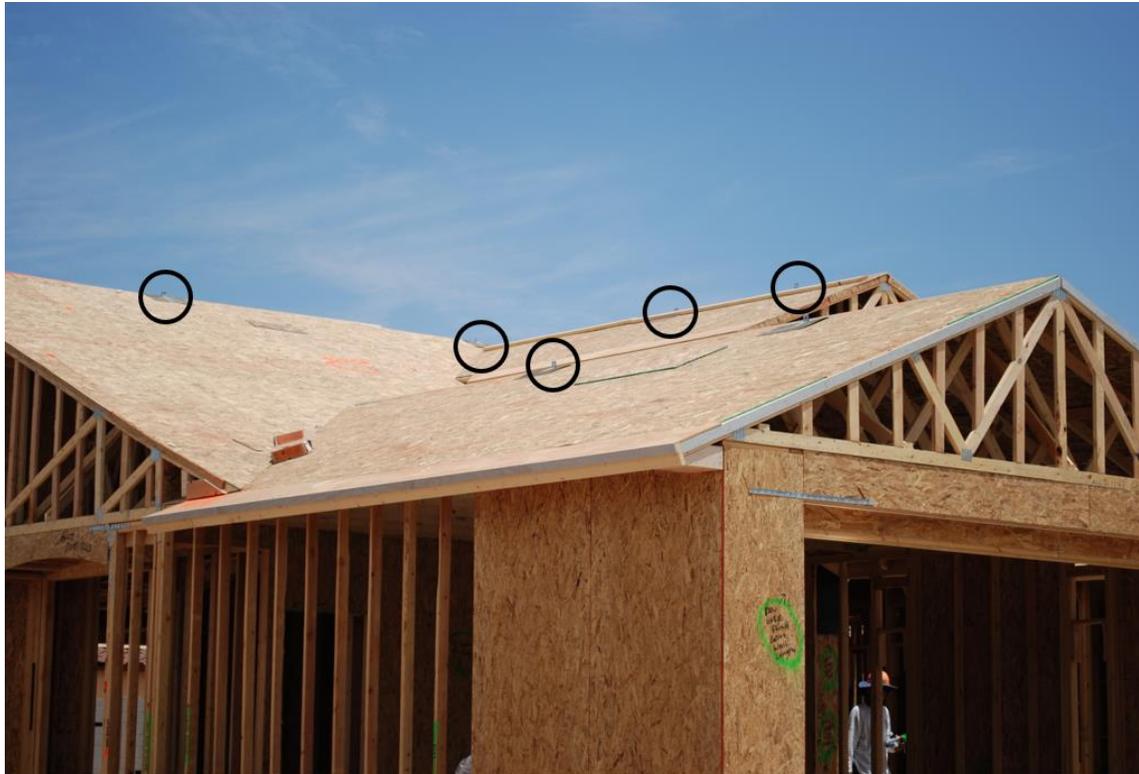
Figure 2. Another view of the completed structure. Circles denote anchors.

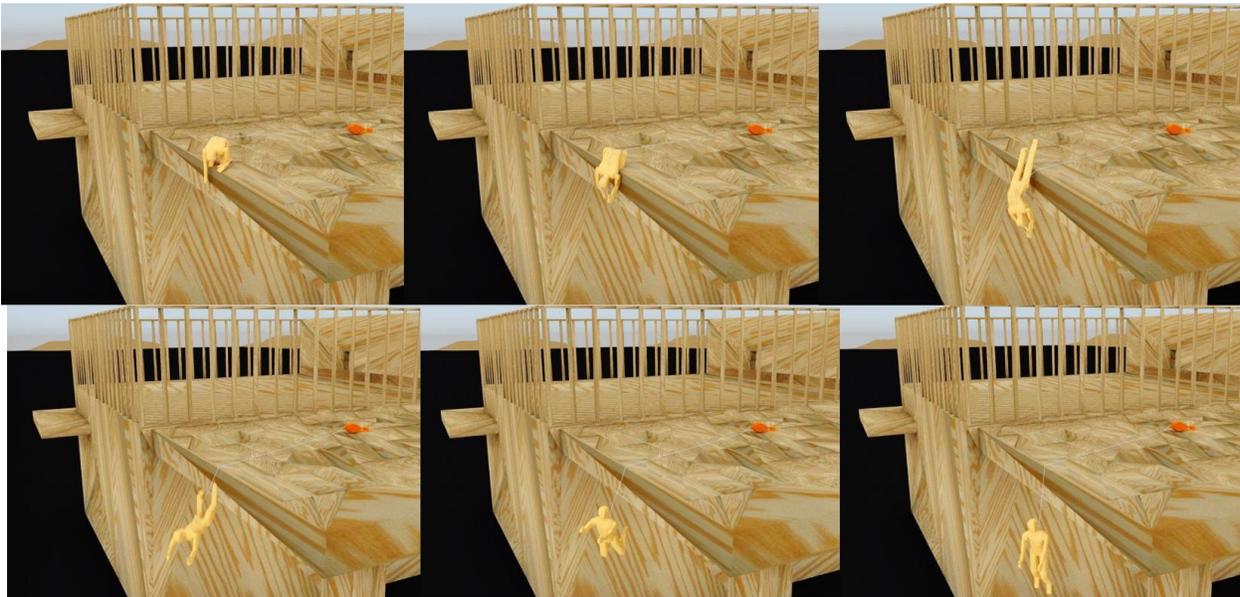
Demonstration of fall kinematics

There was a witness who watched the entire event while standing three feet in front of the worker. According to the witness, the worker went to the leading edge of the structure to assist with the moving of a roof joist. The two workers were going to remove the joist and reposition it later. According to the worker who fell, he leaned out over the edge and grabbed the joist so that when the nails that were securing the rafter were removed, the rafter would not fall on his coworker. Unfortunately, the rafter was partially supporting the sheathing the worker was kneeling on as he leaned over the edge. Immediately upon the removal of the last fastener, the sheathing beneath the worker broke from his weight. Because he was leaning forward, the worker began falling face-first to the ground below. The following sequence demonstrates the worker’s fall.

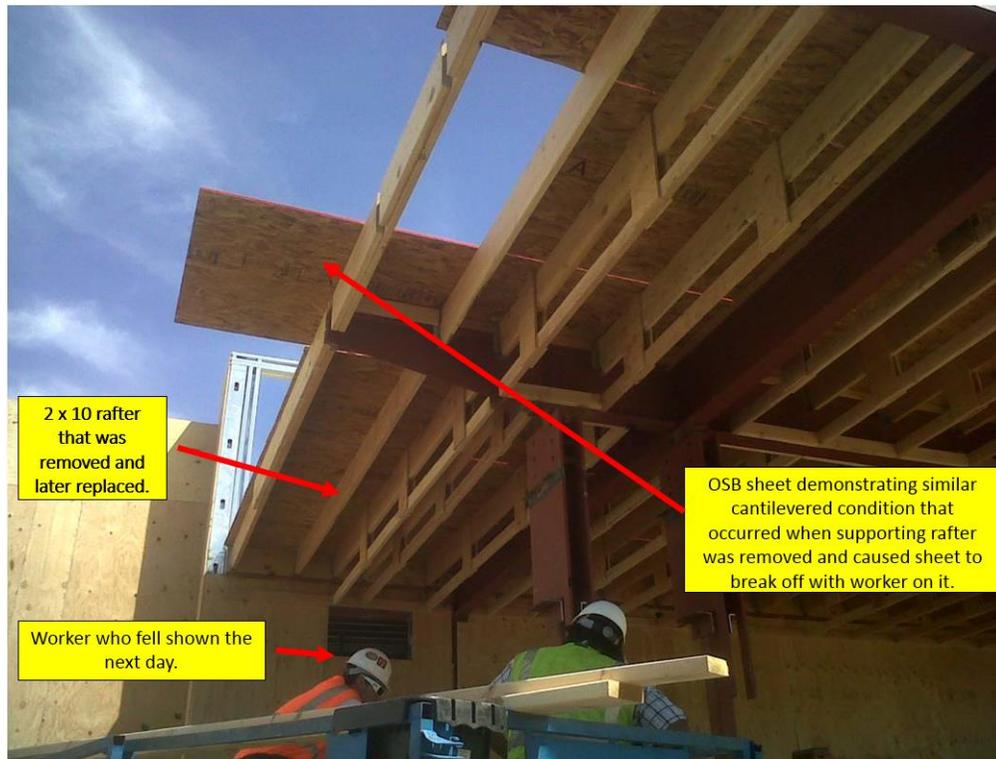
Figure 1. Demonstration of conditions that occurred to cause fall.

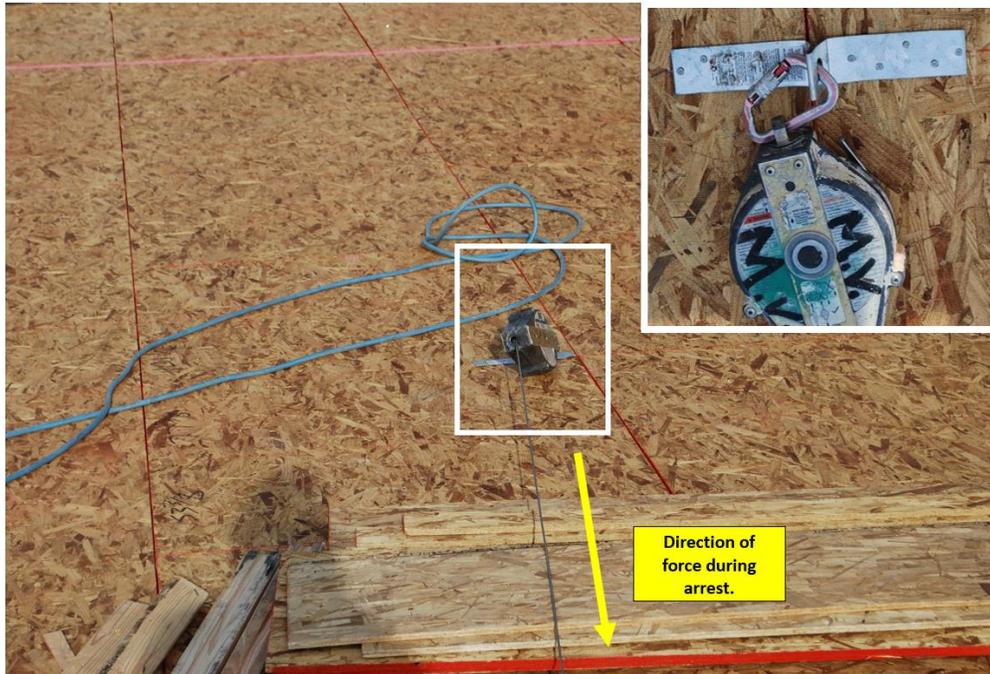
Figure 2. Demonstration of direction of load applied to SRL and anchor.
Inset: SRL and anchor three days before incident.

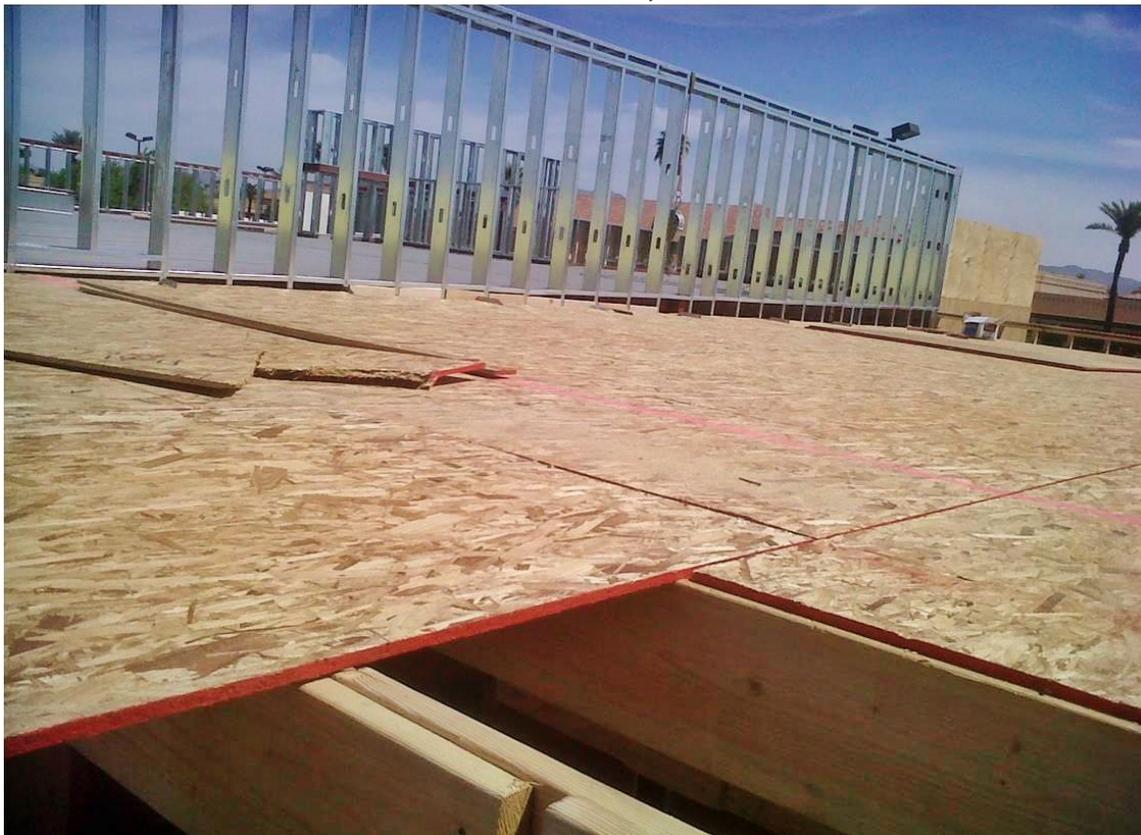
Figure 3. Roof area day after incident. No damage or deflection of roof. No withdrawal of anchor from OSB sheathing.

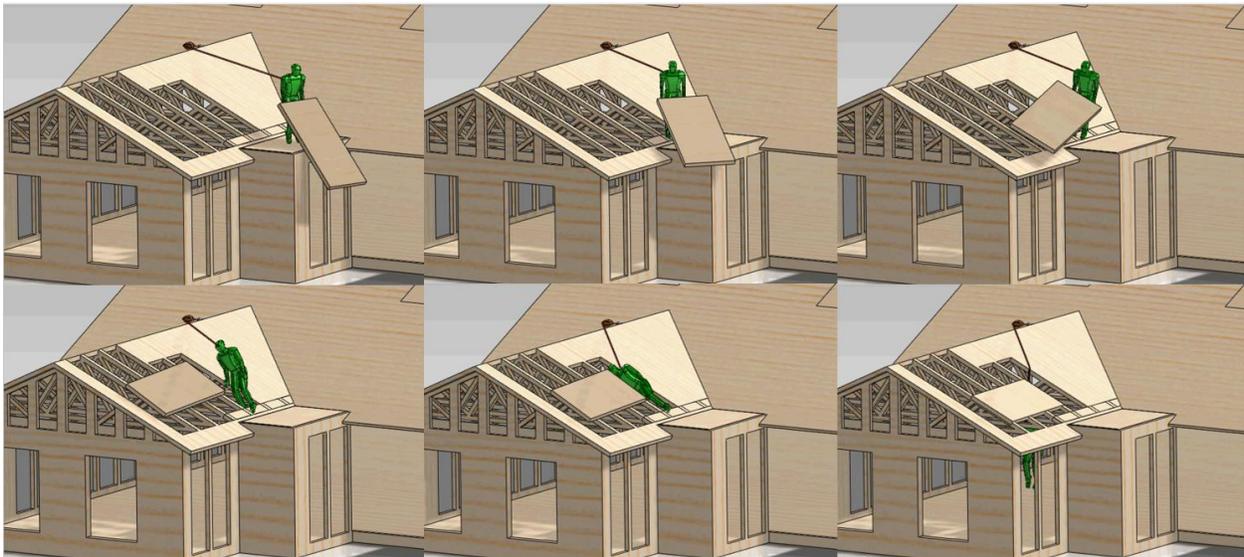
According to the statement by the worker, at the time of the incident he was lifting a sheet of OSB onto the roof to be installed. At one point the worker says he was walking backwards up the roof. As he was heaving the 4x8 sheet of material, he stepped into an area that had not been sheathed. As he fell through the opening between the trusses, he dropped the OSB and it slid down the roof. The PFAS engaged the worker and arrested the fall at the point where the worker fell below the truss top chord. The kinematics of the fall are illustrated in the following sequence.

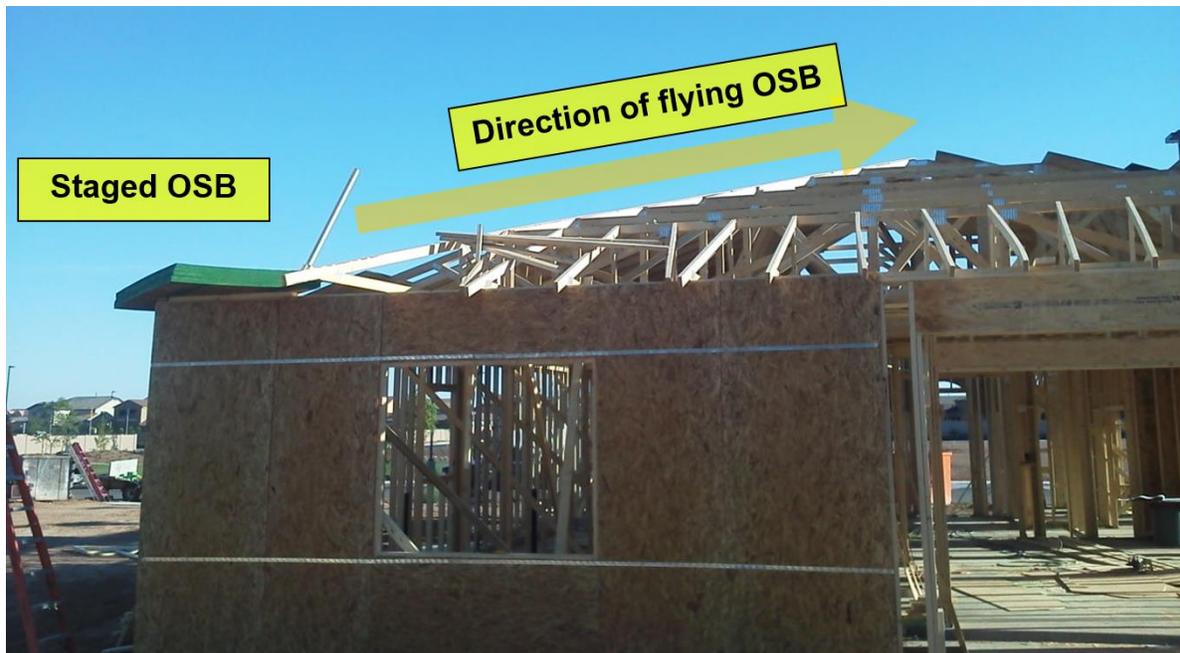
Figure 1. Path of OSB when caught by the wind.

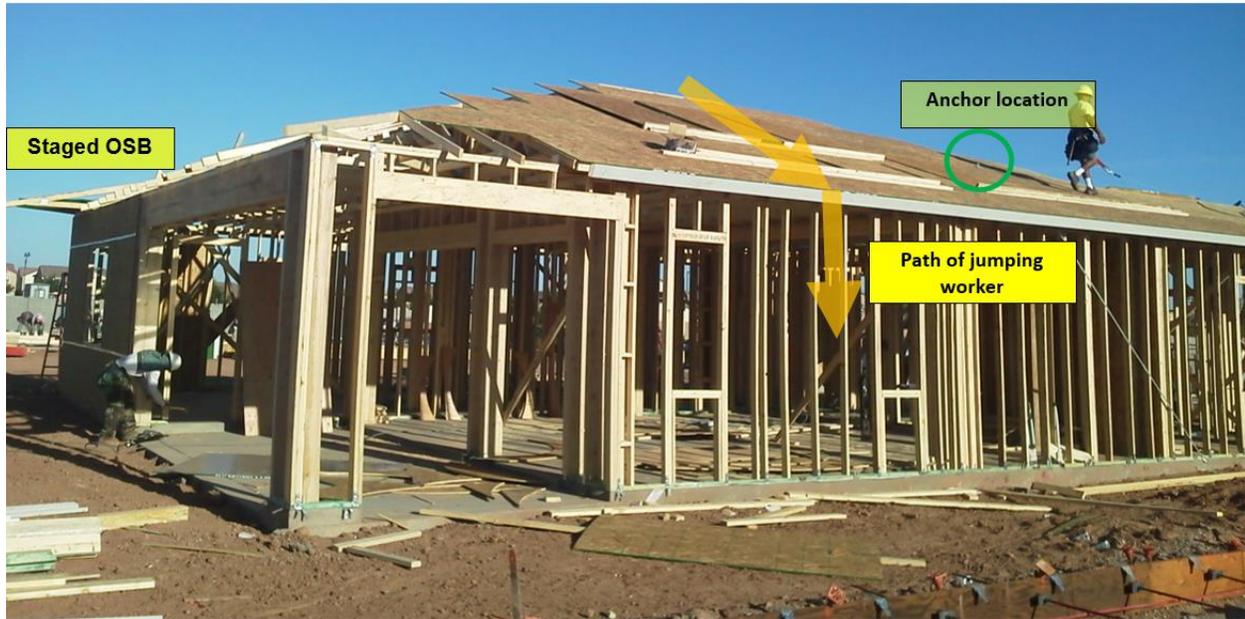
Figure 2. Area where worker attempted jumped to avoid flying OSB.
