**FATALITY ASSESSMENT AND CONTROL EVALUATION  
PROGRAM (CA/FACE)**

**A Tree Feller Dies When Struck By a Tree Limb  
While Felling a Fire-Damaged Tree  
Case Report: 17CA004**

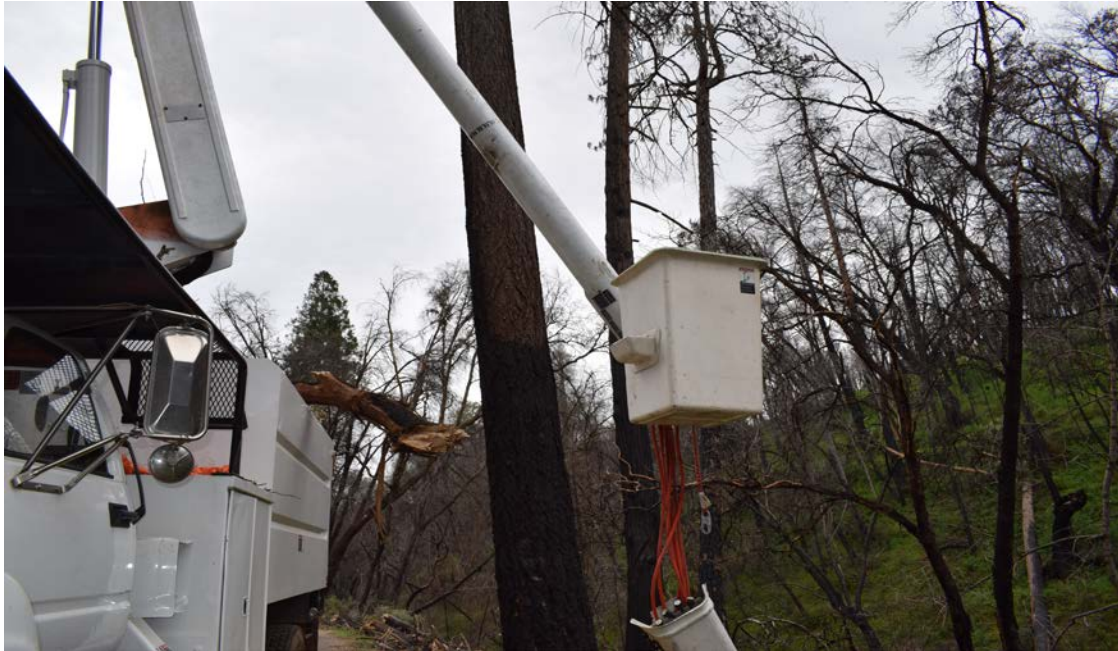
This time, as the excavator pulled, the spar initially moved as intended, but then abruptly changed direction and fell (at a right angle to the rigging line) towards the bucket truck. The upper part of the tree section struck the elevated boom arm and slid down the sloped arm towards the bucket, striking the victim and bouncing him out of the bucket (Exhibits 1 & 2). As he hung suspended from his body harness, his co-workers were able to reach and unclip him, and lay him on the road. The time was approximately 11:10 am.

Exhibit 1. The bucket truck after the victim was struck and knocked out of the bucket.  
Photo used with permission.

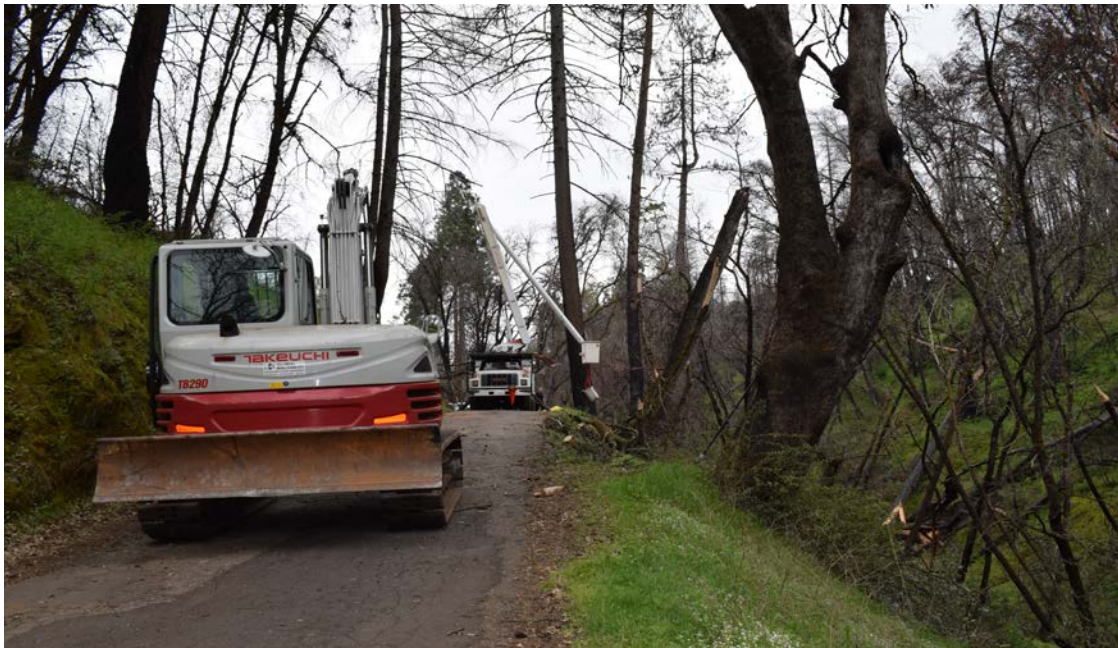
Exhibit 2. The trunk of the tree to the right of the road, and the bucket truck and mini-excavator used by the crew. Photo used with permission.
