# **CPWR TECHNICAL REPORT**

## **Analysis and Control of Crane and Aerial Lift Hazards**

**May 2007**

Written by David V. MacCollum P.E., CSP

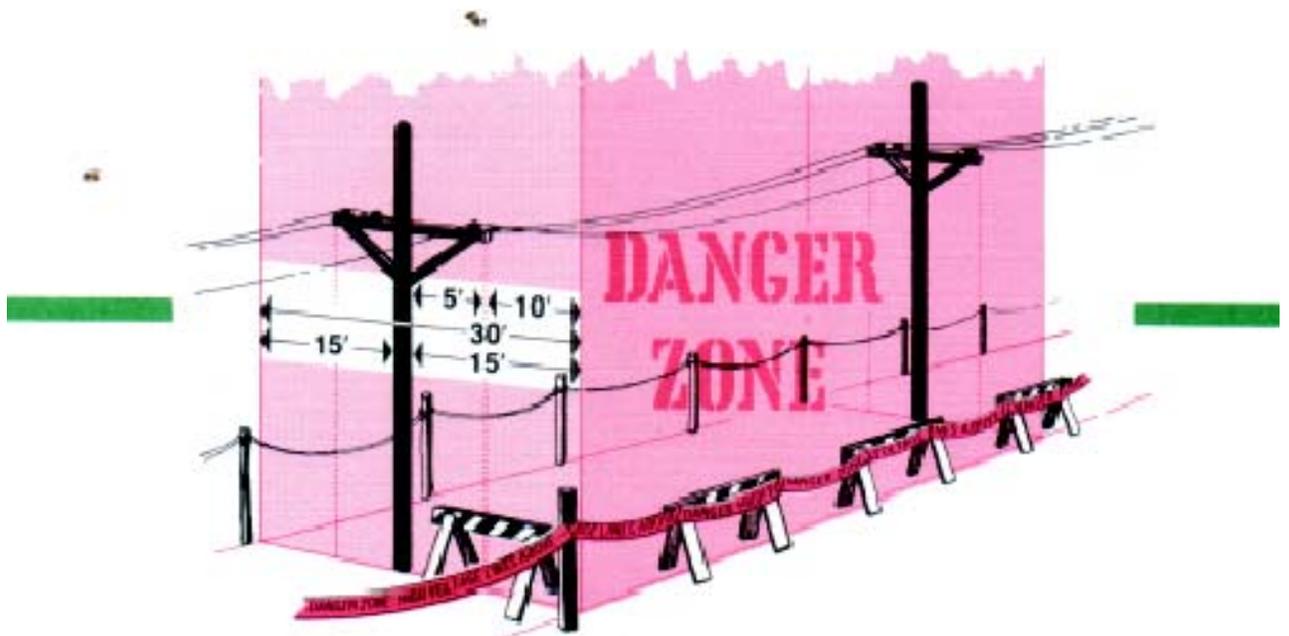
**Illustration 16: Danger Zone**

**Map and Barricade the 30 foot wide Danger Zone (15 feet on each side of the powerline poles).**

1. Require construction plans and specifications to remove, relocate, bury, or de-energize powerlines *before* the crane or aerial lift appears at the work site.
2. Establish a worksite procedure to always barricade, flag, or mark the Danger Zone *on the ground*, where it is easily seen and shall not be violated (see Illustration 16). OSHA should include a requirement for a standard written procedure to first map the 10-foot powerline danger zone on the ground as shown in Illustration 16. This practice will provide guidance on how to stay out of the danger zone created by powerlines to both the crane operator and the rigging crew.
