# Fall Protection

## Structural Efficacy of Residential Structures for Fall Protection Systems

# Fall Arrest Save Evaluation Report 10-1-07

FASE Identification 10-1-07

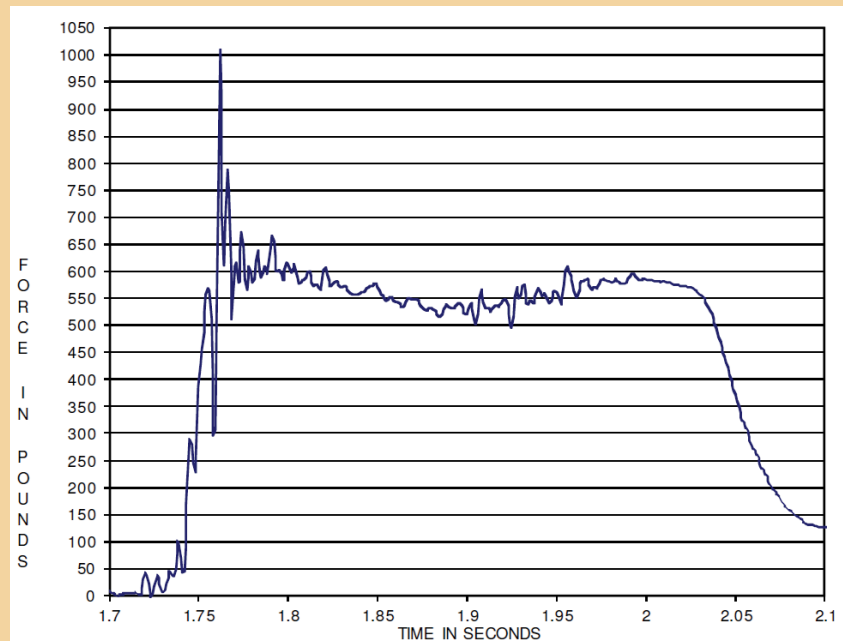
**Figure 1**  
**Typical Certification Test Curve for Ultra-Lok SRL**

Figure 1 presents a typical certification test curve for the SRL used. The certification tests provided by the manufacturer all exhibit a performance curve with common characteristics. When an SRL lanyard is first pulled by the test weight at the bottom of the 6-ft fall, it requires approximately 40 milliseconds to initially achieve a short-duration spike of 900 to 1,000 lb. This is considered a transient force and has limited effect, if any, on the system due to the small amount of energy associated with it, as calculated by the area under the curve. After the initial spike, the curve drops and exhibits the braking behavior of the SRL. For example, the curve in Figure 1 had an average arresting force of 568 lb. and an arrest distance of 32.5 in. In accordance with ANSI/ASSE Z359.1, the manufacturer conducts qualification tests on self-retracting lanyards at temperatures of -40 °F and 130 °F at 85% relative humidity. It is expected that SRLs will perform in any climatic condition.

An important consideration for PFAS users is that the manufacturer's tests do not simulate the system's compliance when used in the real world. Certification tests are conducted using a test weight attached rigidly to the lanyard and dropped straight down. In actual use, a fall causes the lanyard to drop to the level of the roof's surface; it then gets pulled over the edge where the worker falls. As the SRL begins to lock, the lanyard begins to pull on the D-ring of the worker's harness and tightens around the worker. This pulls the harness into the worker's clothing and compresses

the soft body tissues directly under the harness. This progressive process of pulling the slack out of the system attenuates the rate at which the lanyard is drawn tight and limits the peak load on the system. The onset rate of load application is essentially damped through compliance of the system. Therefore, instead of a large spike as seen in laboratory testing, a lower parabolic or trapezoidal-shaped initial curve would likely occur.

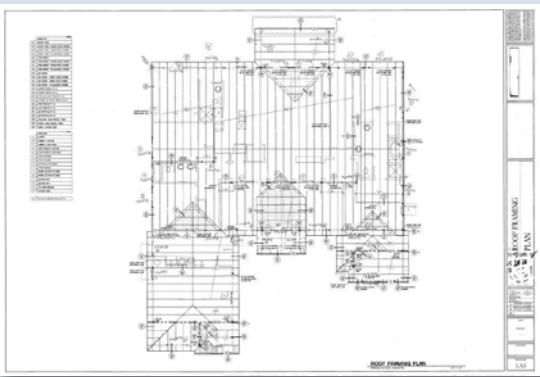
Figure 1: Truss system blueprint

Super Anchor Safety Bar was used with temporary bracing installed on truss system (see photos from incident scene) according to field interpretation of SBCA BCSI B2.

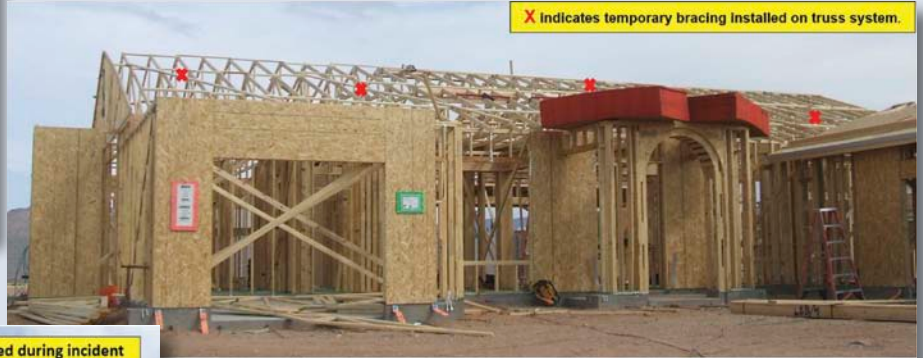
X indicates temporary bracing installed on truss system.

Photo 1: House in frame just after trusses erected and set. Stack of OSB above entryway to the right was being put into position when worker fell.

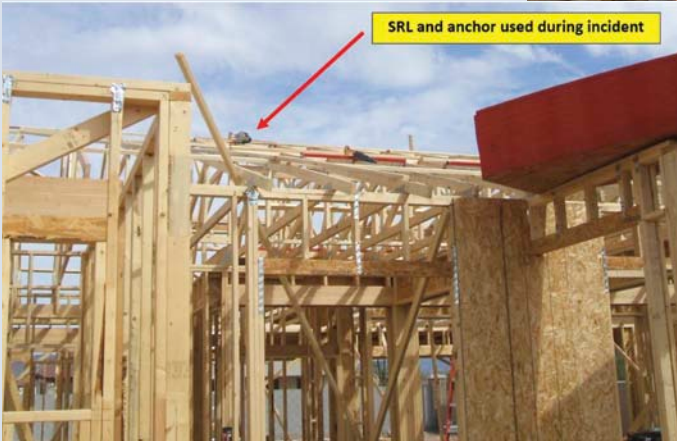
SRL and anchor used during incident

Photo 2: PFAS anchor and SRL used by the worker. All equipment left in place for photo.

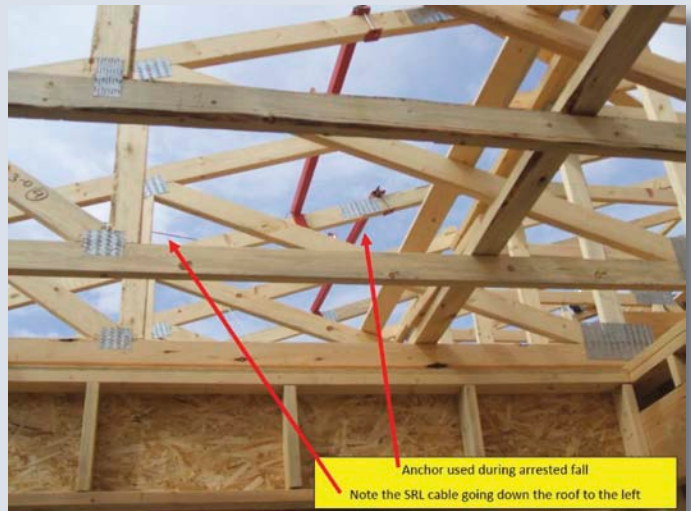
Anchor used during arrested fall  
Note the SRL cable going down the roof to the left

Photo 3: Underside of truss system and anchor used in arrested fall.

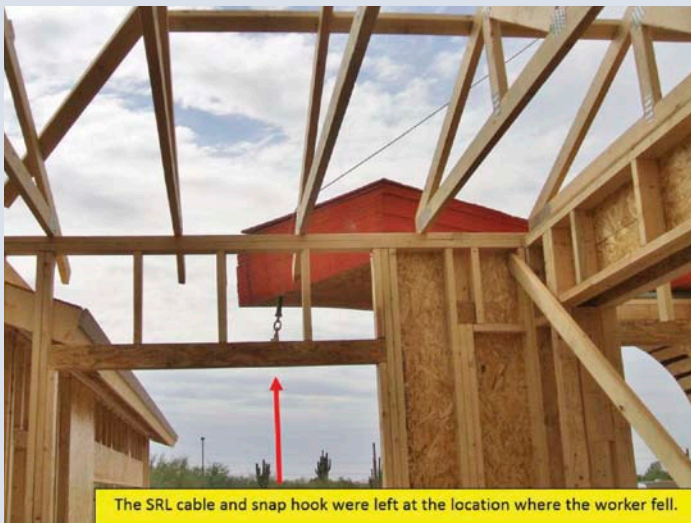
- The worker fell between truss tails. As he fell, the lanyard passed over the truss tail into the corner created by the tail and top plate, and limited the amount of swing (Photo 4).

The SRL cable and snap hook were left at the location where the worker fell.

Photo 4: SRL cable and snap hook where fall was arrested. Note proximity to truss top chord and wall and path of lanyard over truss tail.

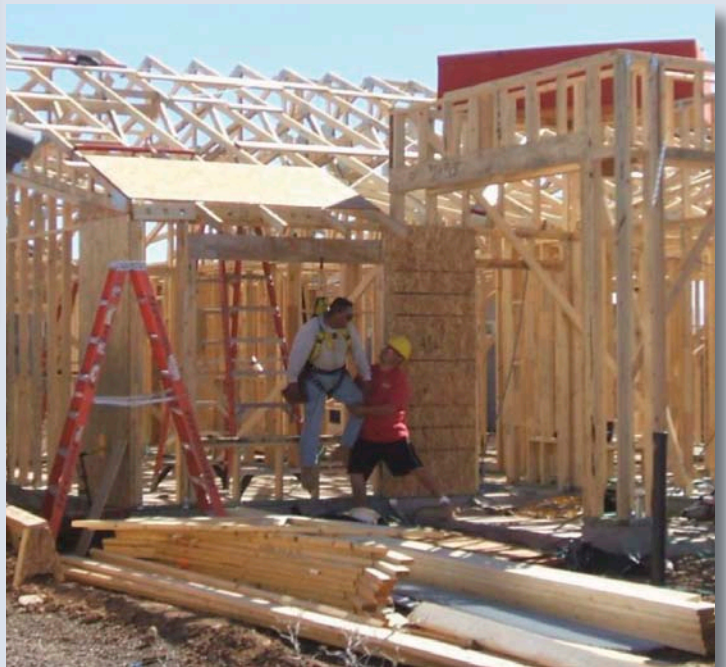
After the arrested fall, both workers demonstrated the rescue at a similar location. The worker who fell is shown in Photo 5 demonstrating his height above the ground where he came to rest and reenacting with the other worker how he was rescued.
