Liquid Oxygen Cylinder Explosion

- Improper methods used to render scrap cylinder unserviceable
- Unsafe modifications to cylinder design

Accident Profile

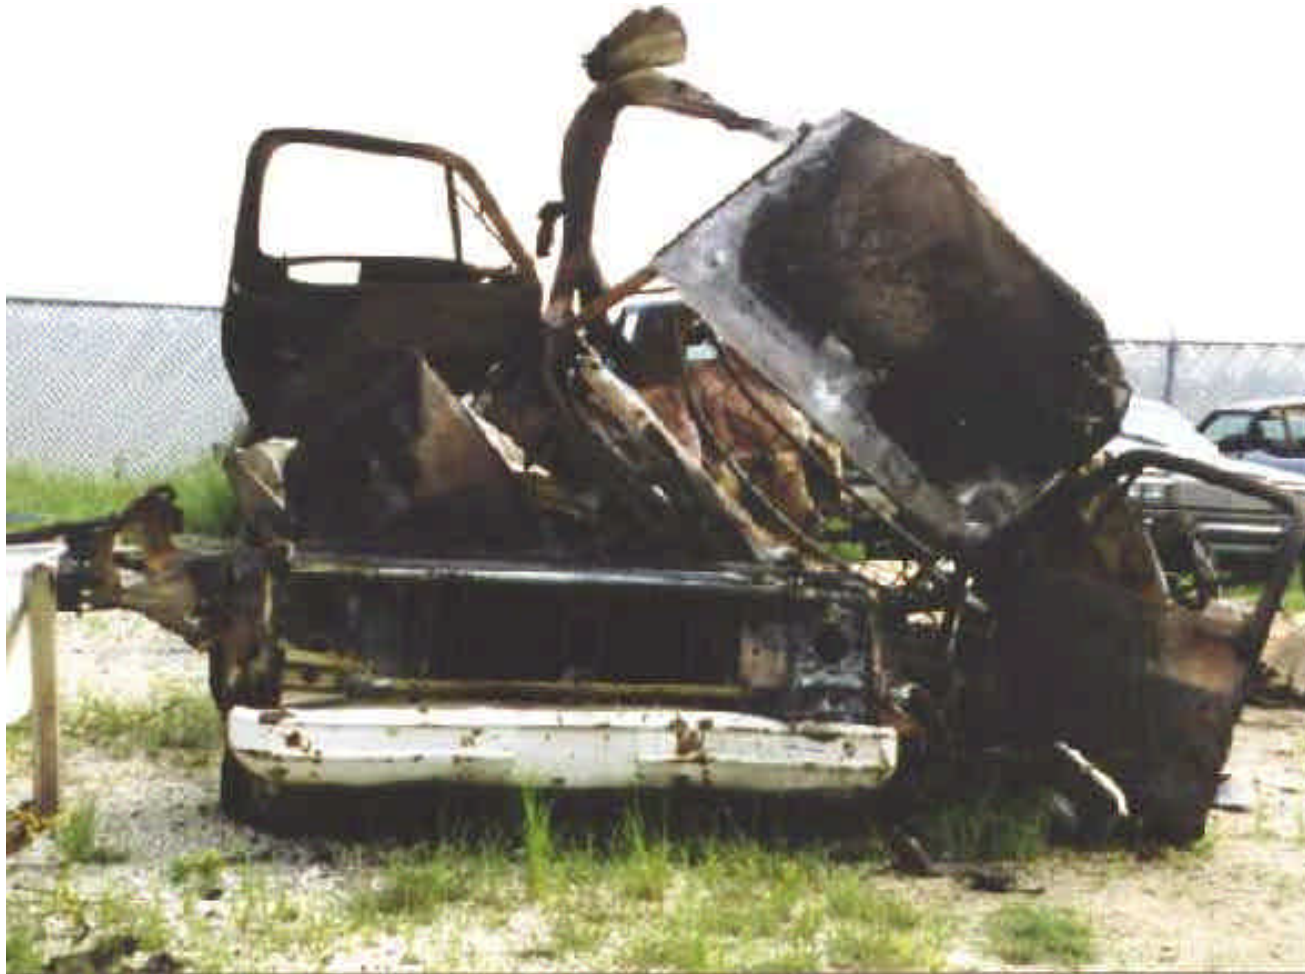
Pickup truck on which the cylinder was being transported

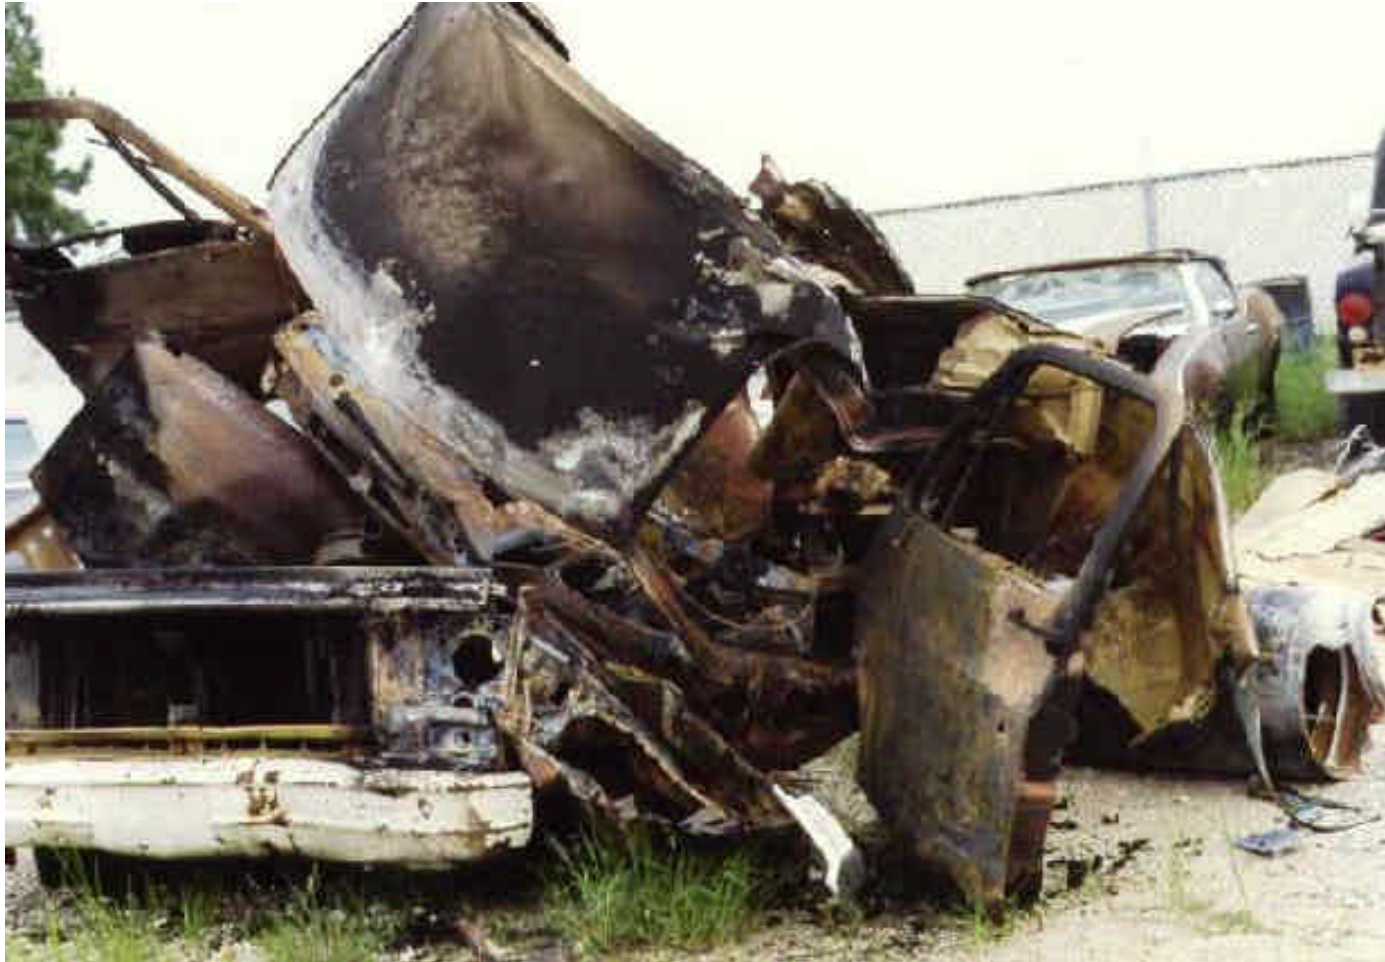
Pickup truck on which the cylinder was being transported

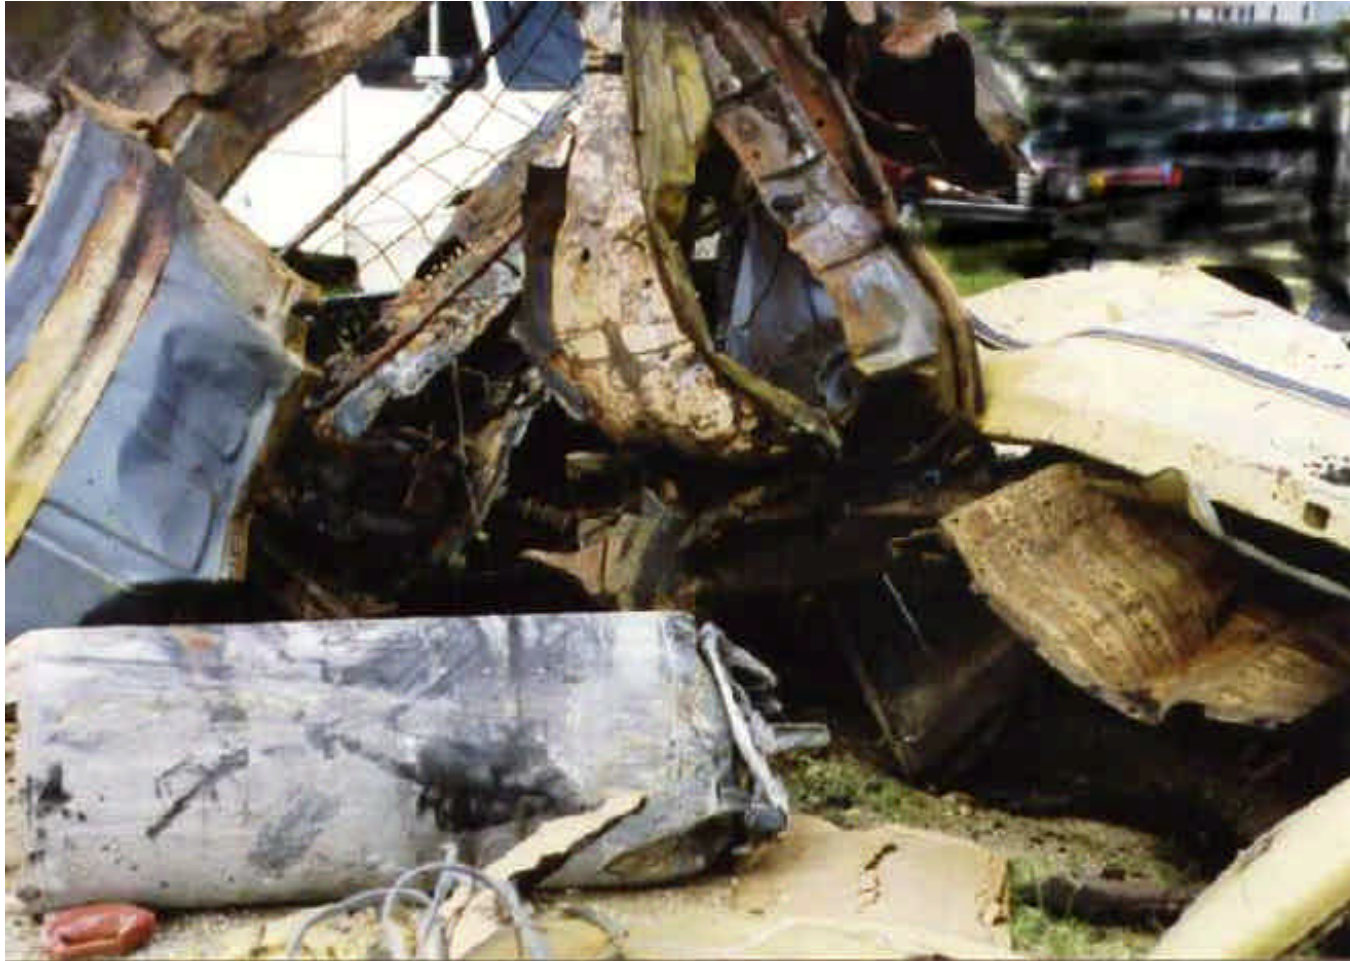
Pickup and cylinder remains

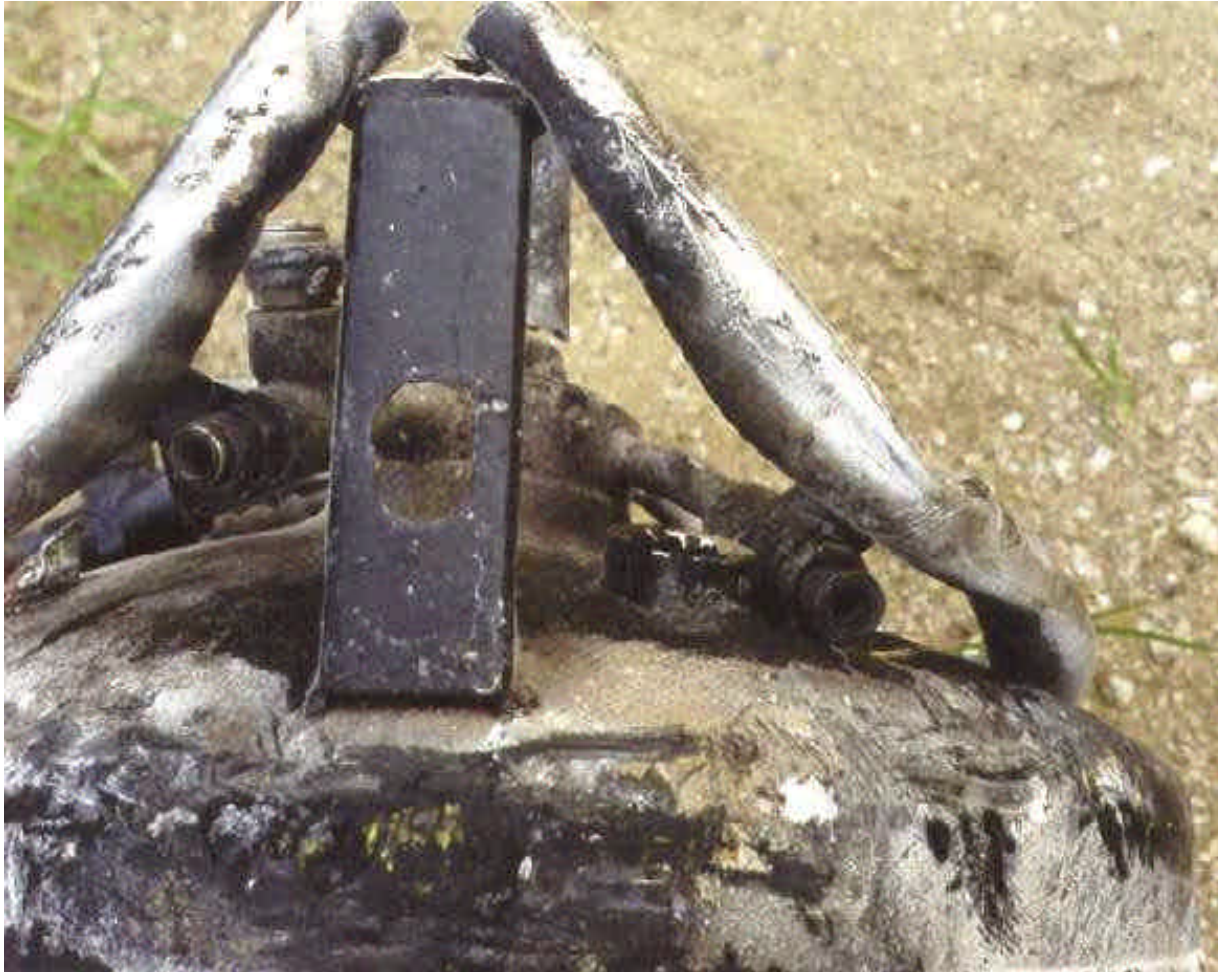
Cylinder top

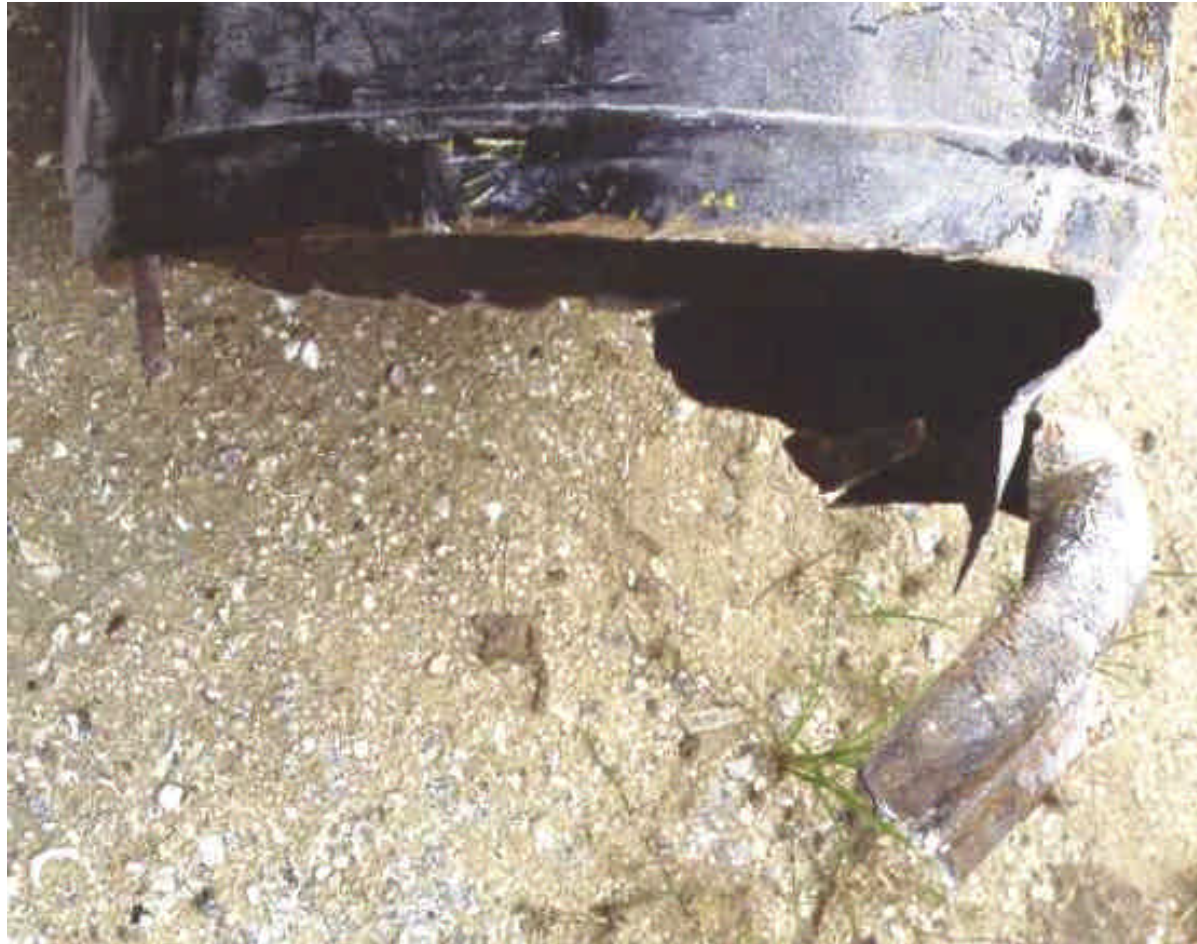
Cylinder outer shell, bottom

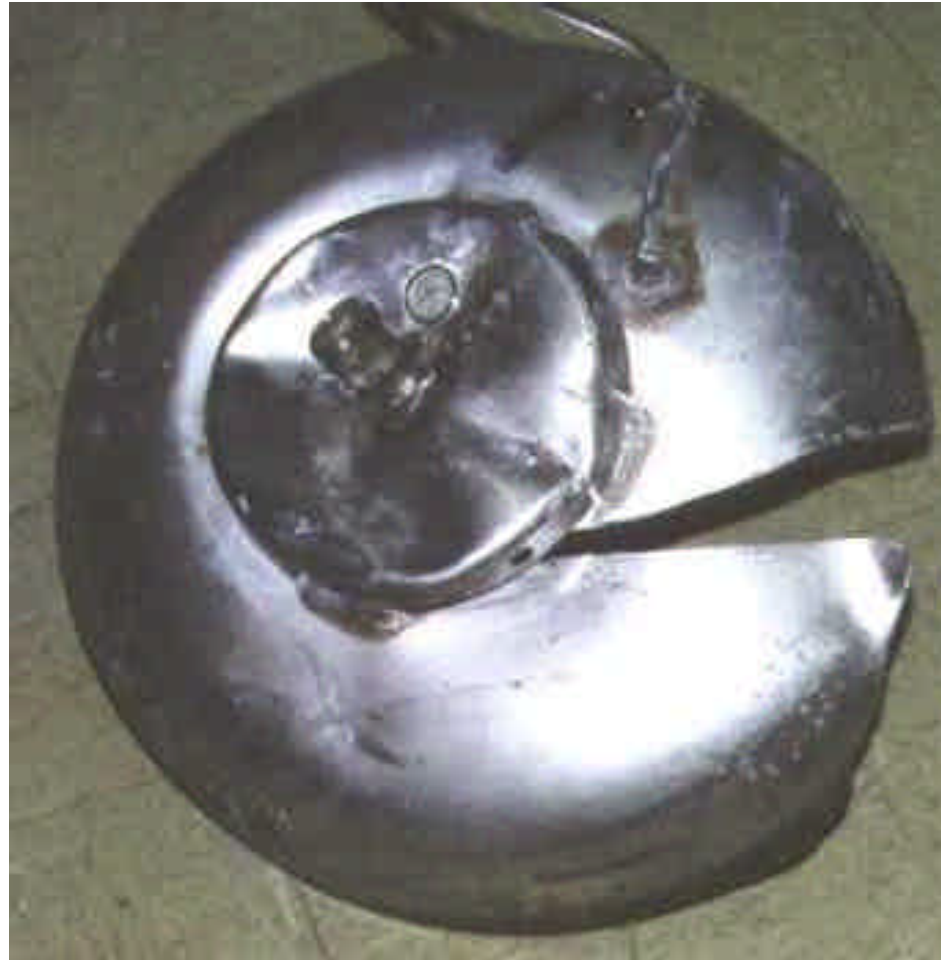
Cylinder bottom shell

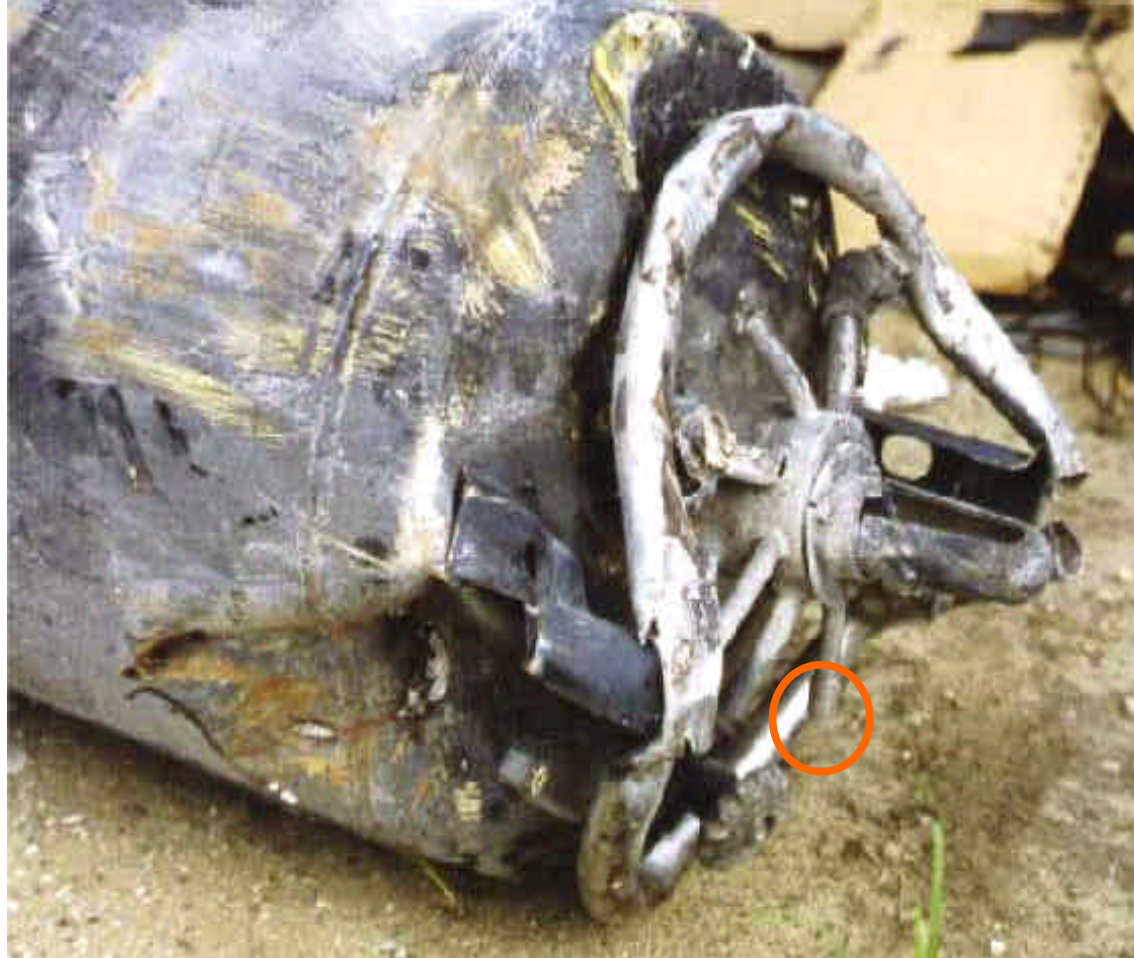
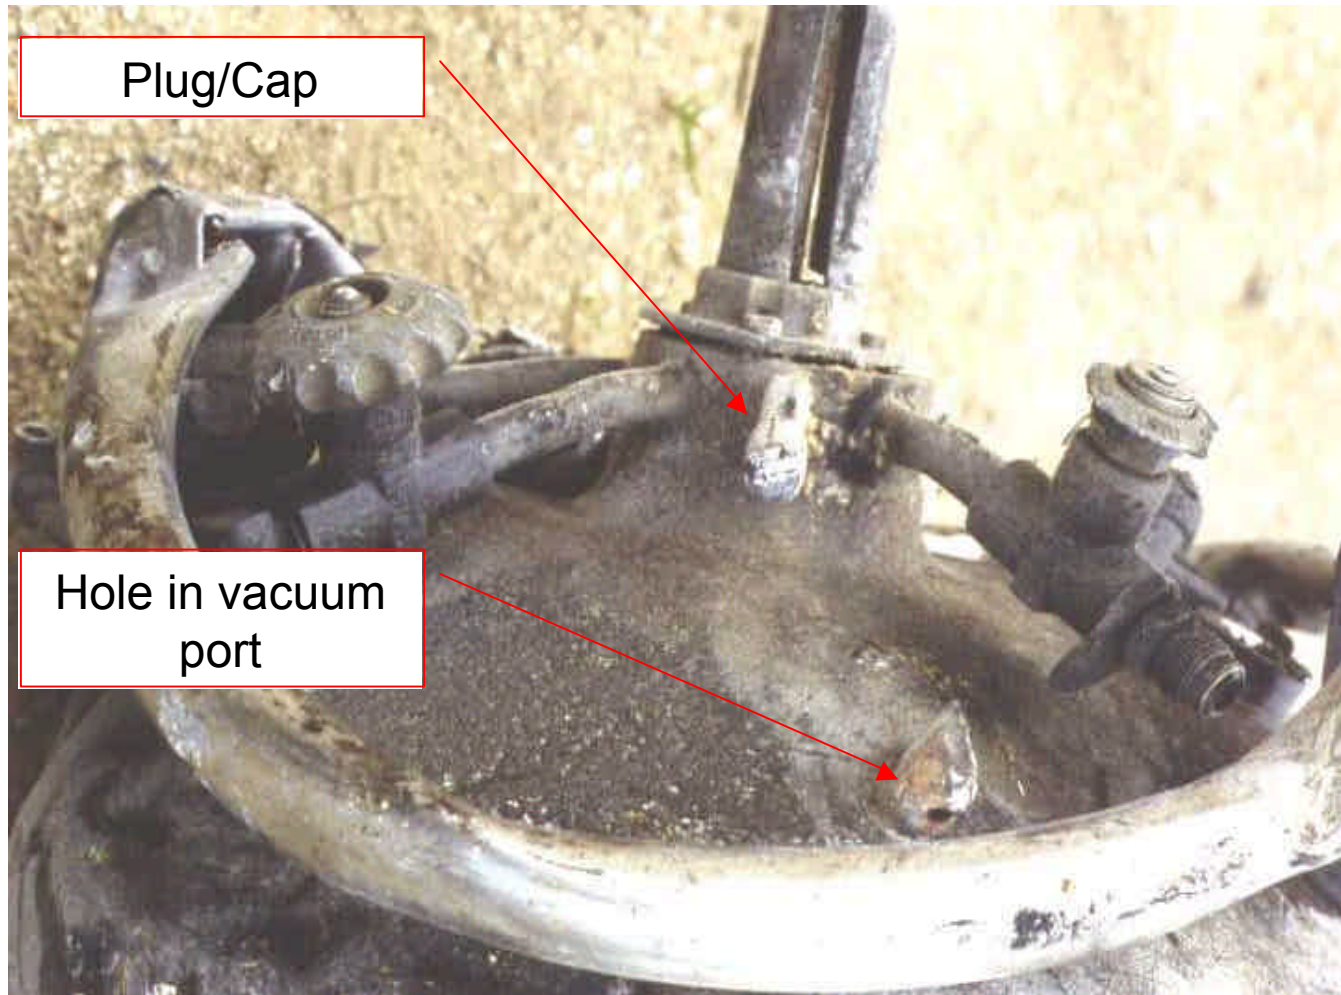
- The PRDs were removed and plugged
- The cylinder was filled while onboard a pickup truck
- The cylinder, which had no vacuum, was now unable to vent excess pressure

PRD location was plugged using a threaded cap

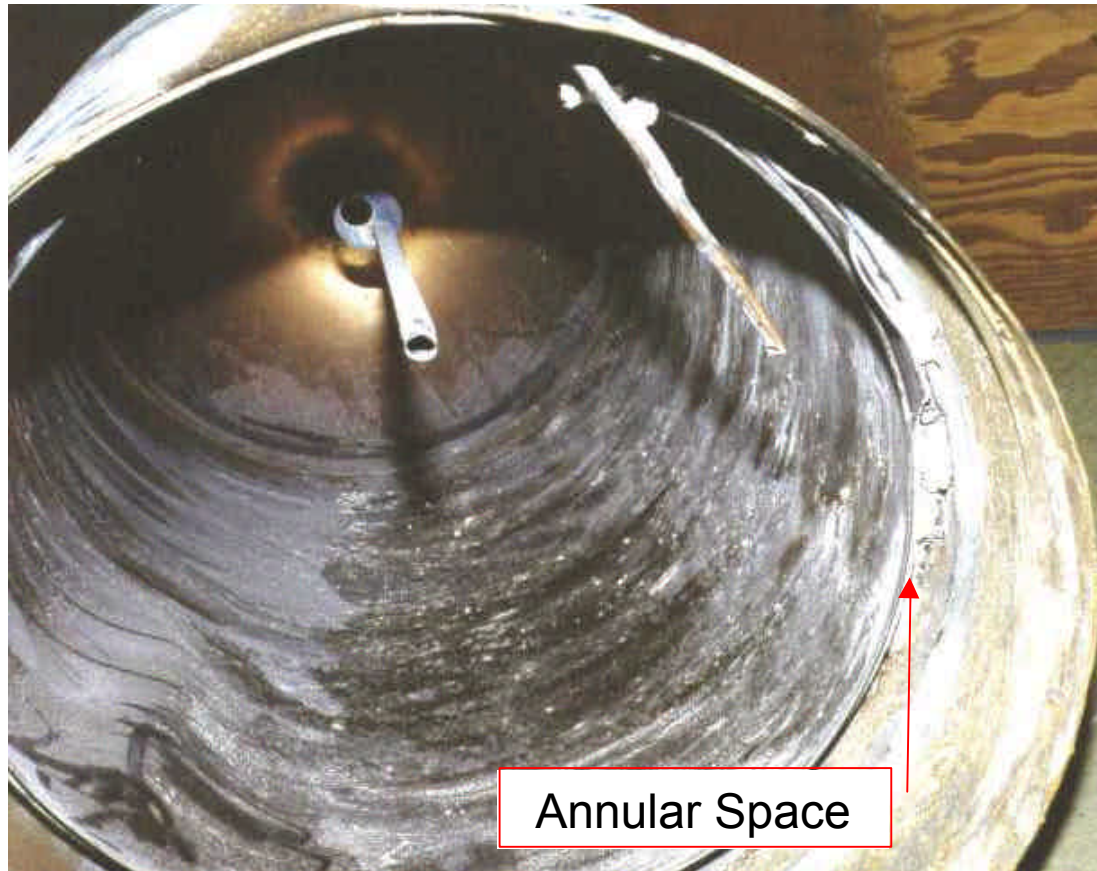
Both inner and outer shells separated at bottom welds

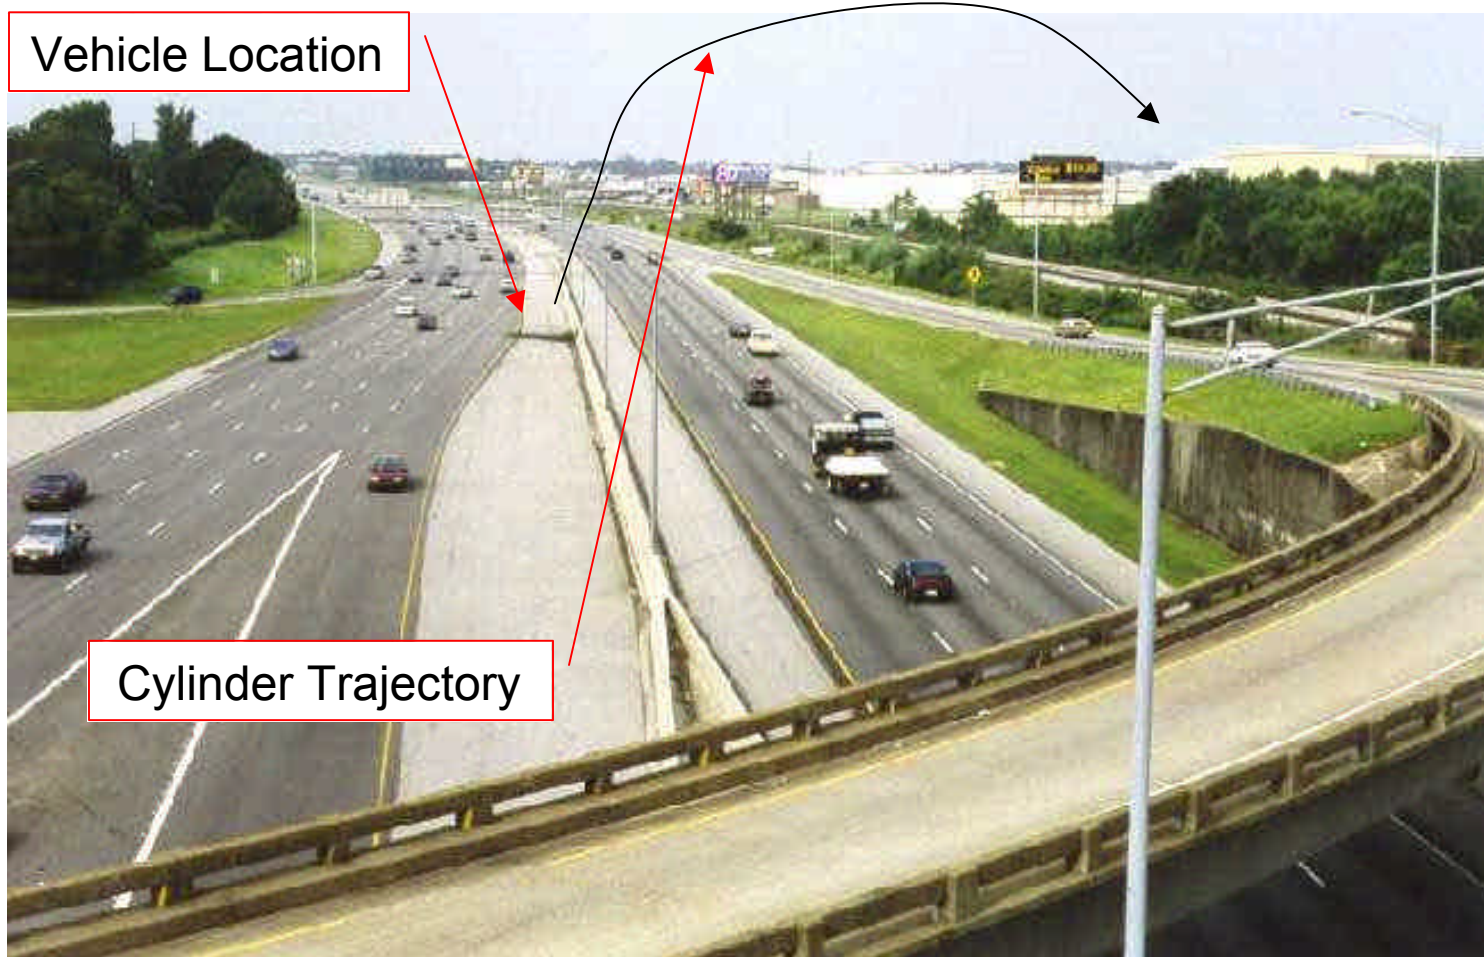
Cylinder exploded at 12:40 PM while transport vehicle was parked on busy Interstate highway

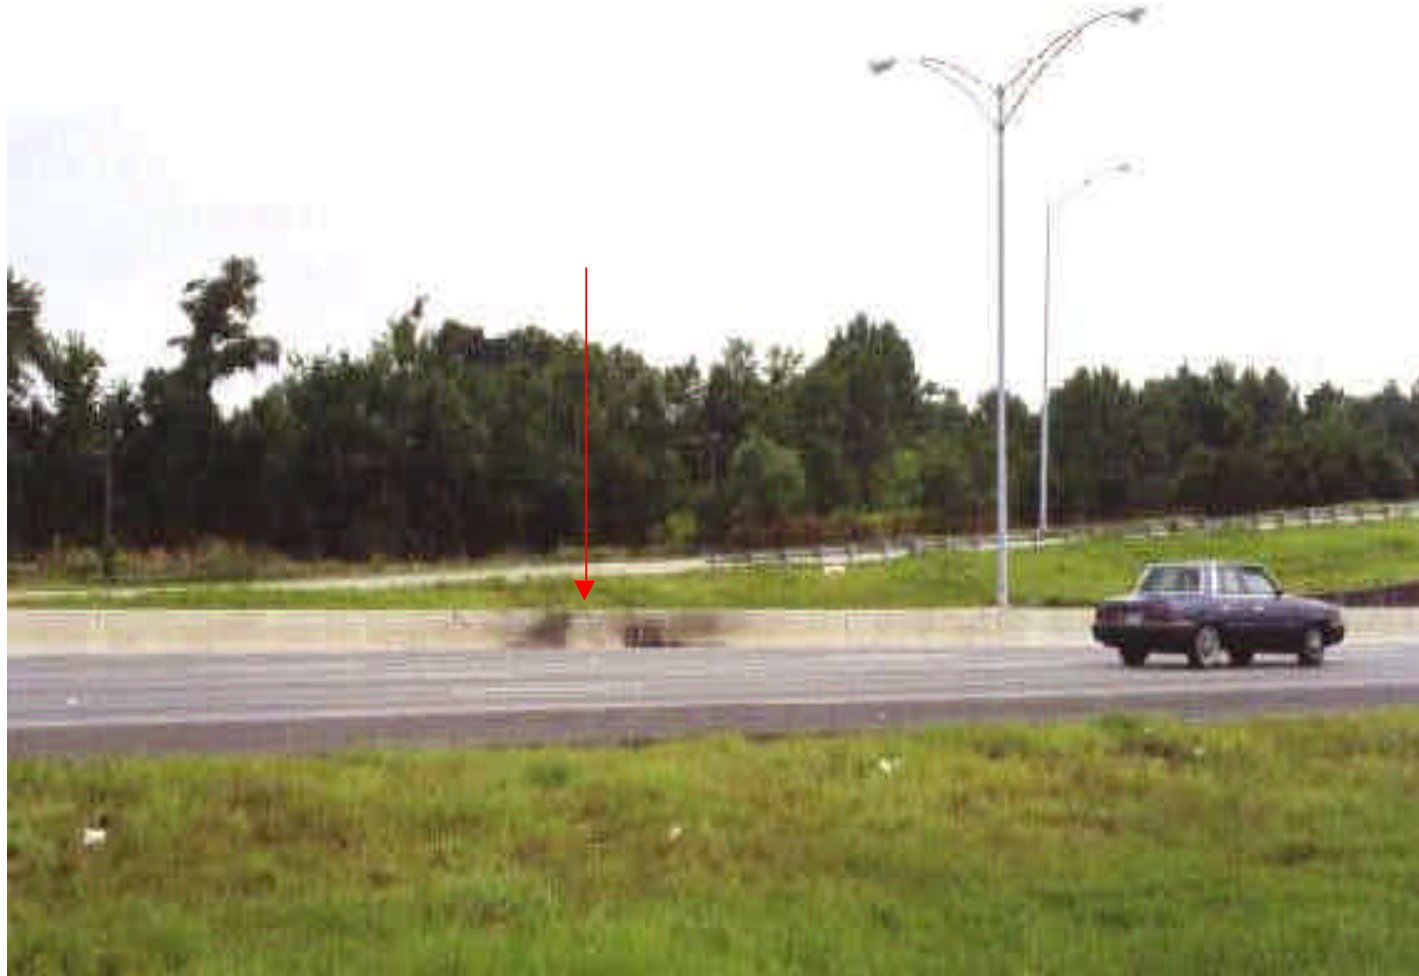
The blast blew one individual across 5 lanes of traffic. The other was blown approximately 40 feet. Both survived

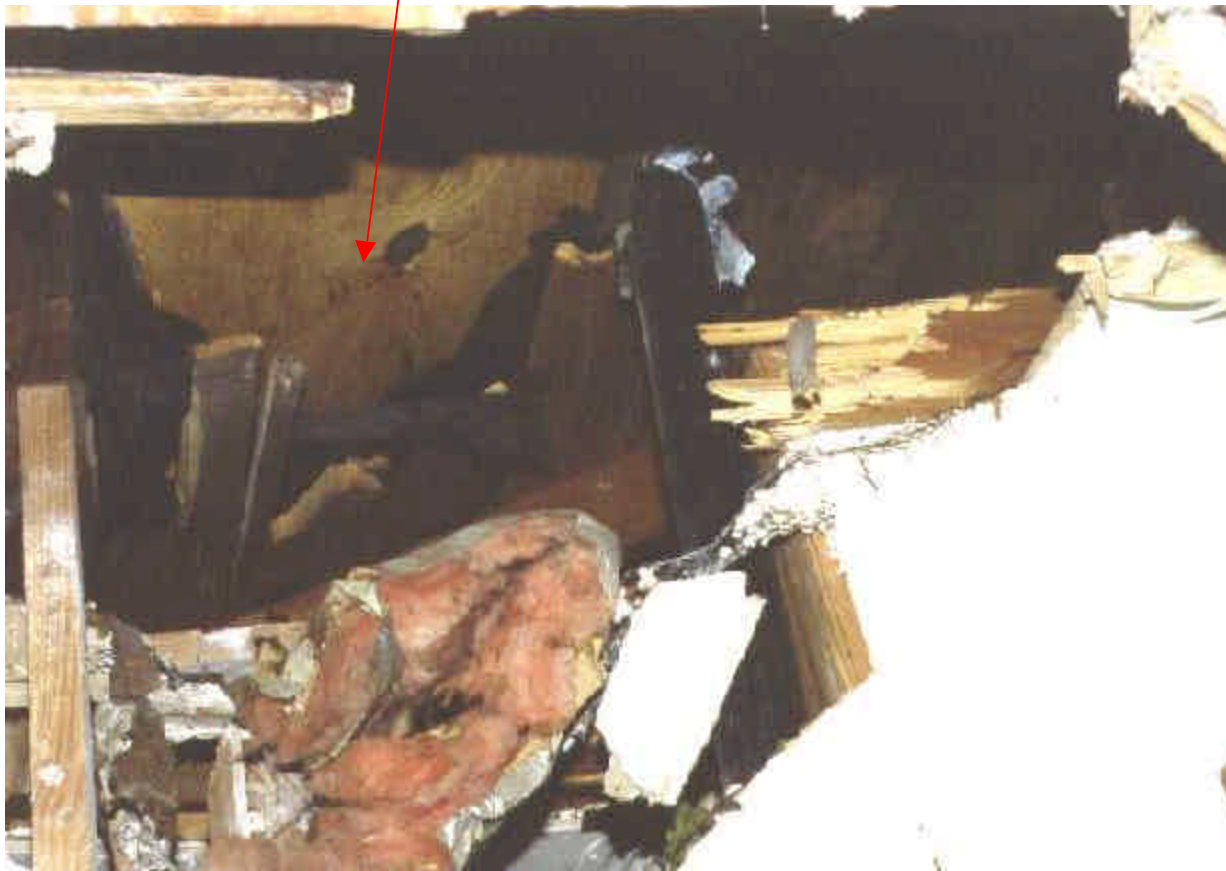
Cylinder flew approximately ¼ mile before plunging through the roof of an apartment, severing a main natural gas line and coming to rest in the living space

Plywood applied over hole in roof

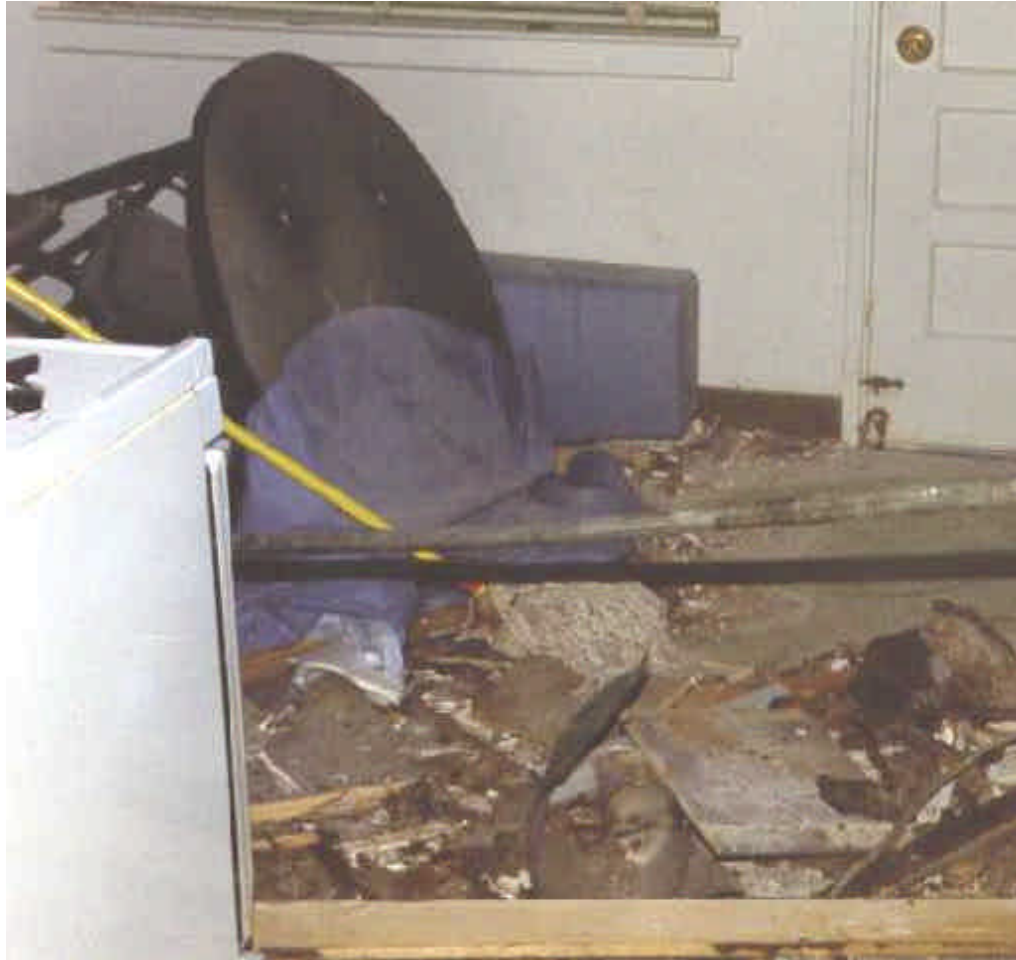
Despite heavy damage, no injuries to apartment tenants were reported

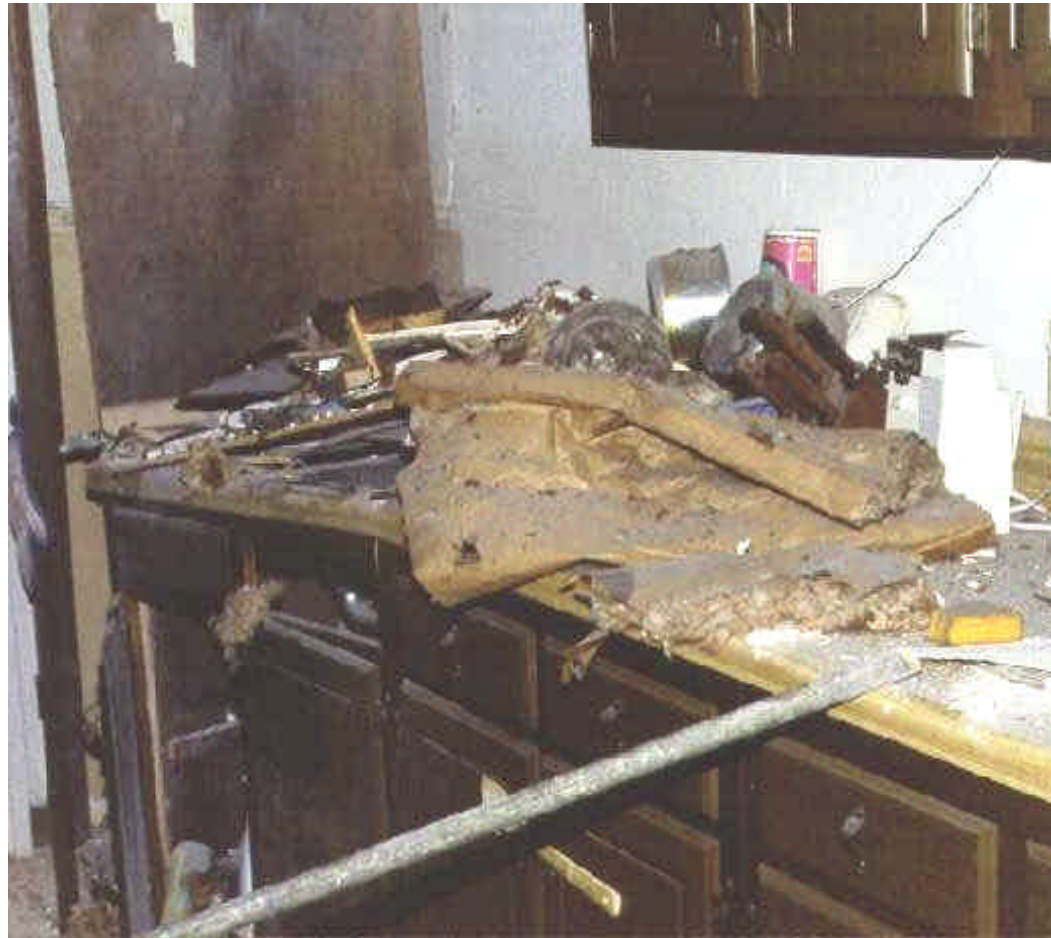
Apartment interior
